ICOMOS New Zealand and
Historic Places Aotearoa Conference
12 November 2022

SEISMIC RESILIENCE – CHALLENGES FOR BUILT HERITAGE
CASE STUDIES

Tracey Hartley, Senior Associate – Salmond Reed Architects

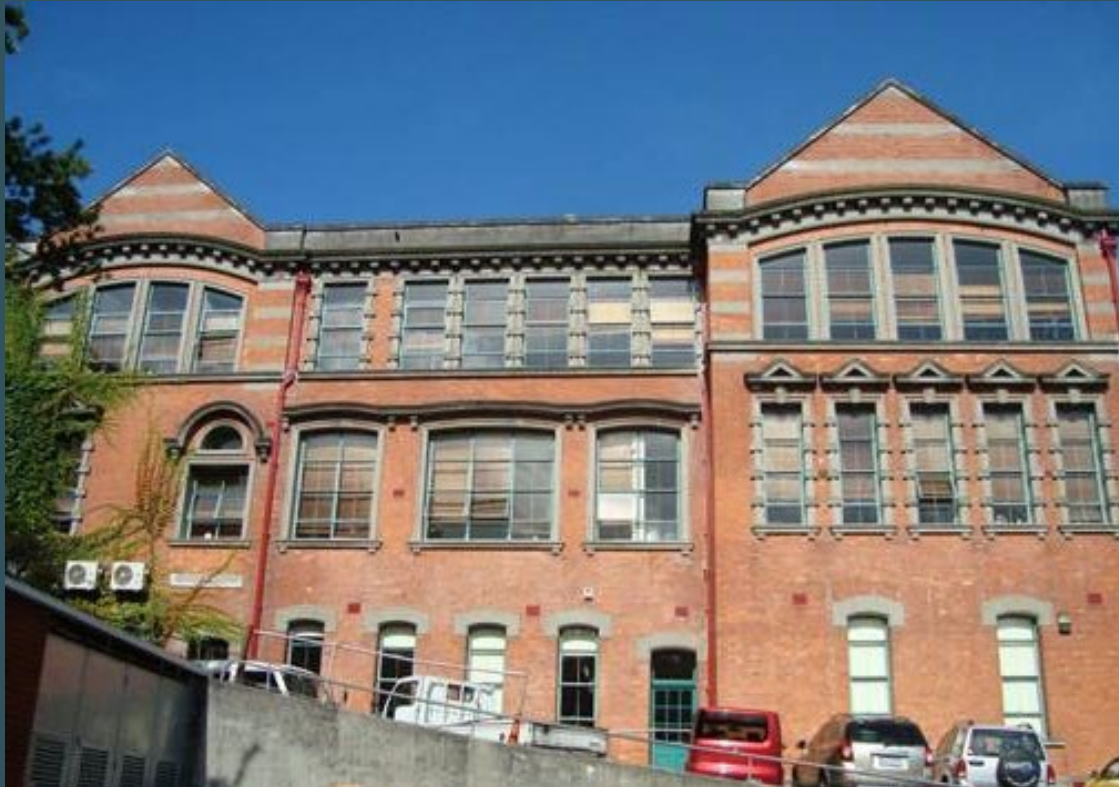
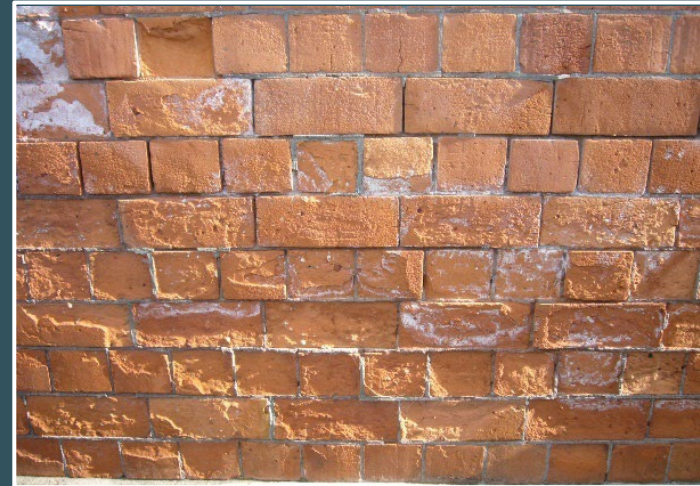
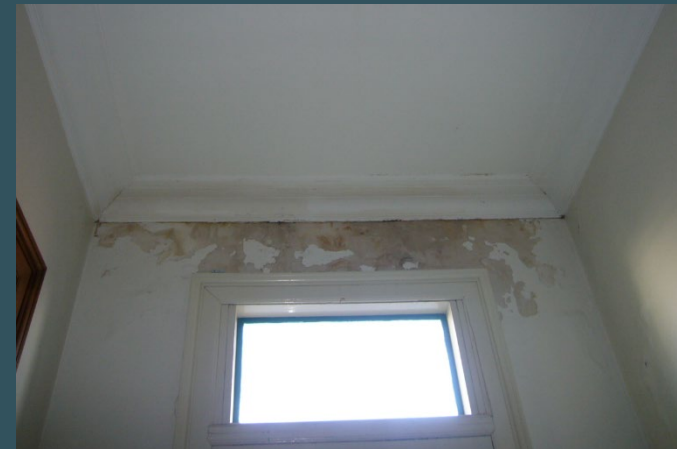
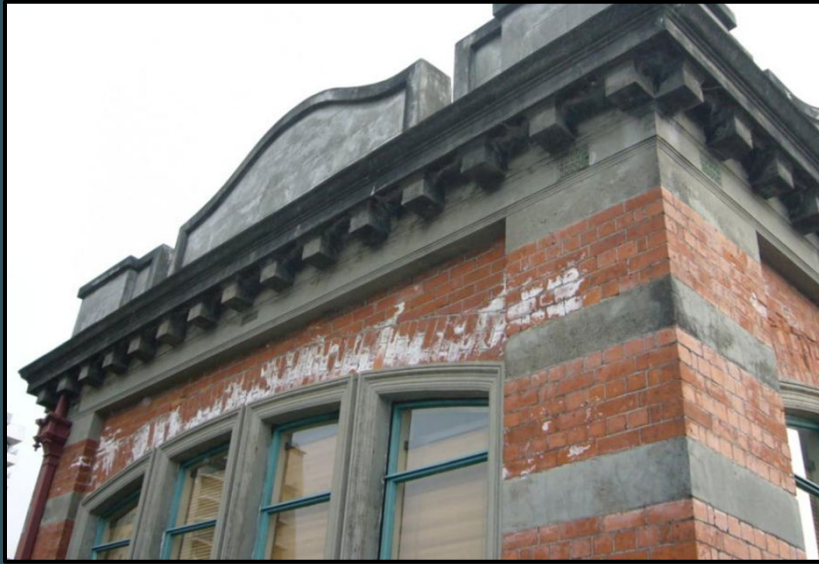
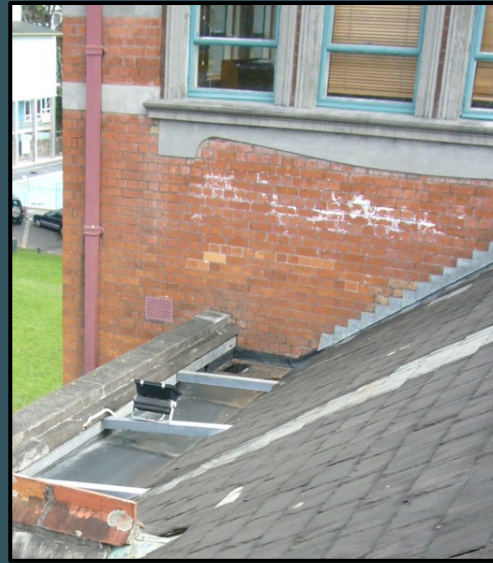
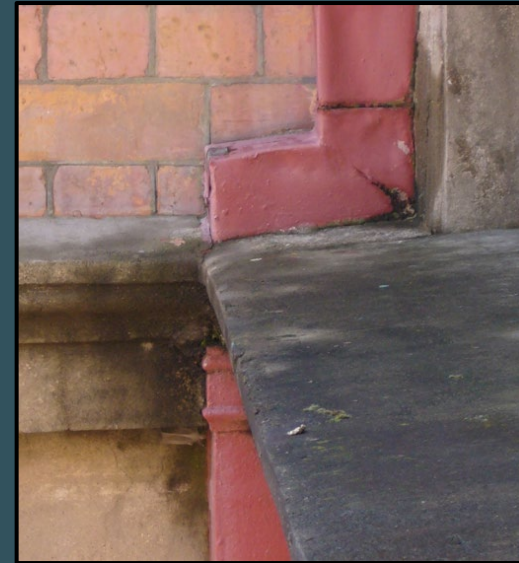
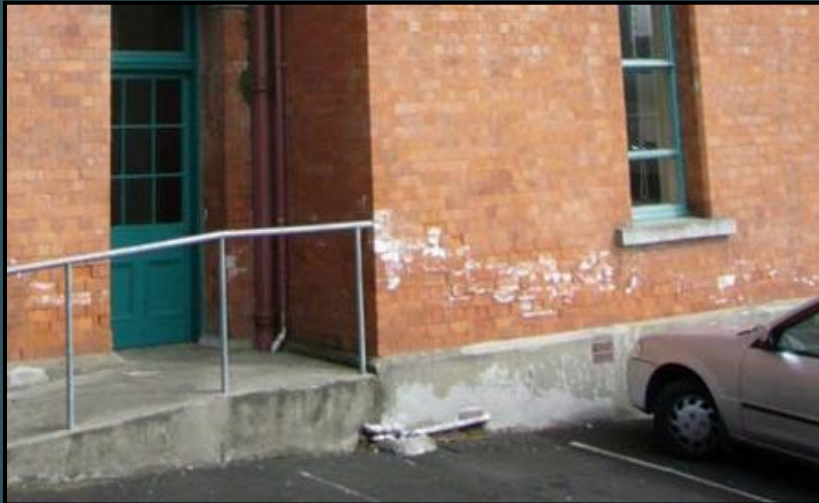
- extensive efflorescence (salts) externally
- water penetration – damp plaster internally
- failure of plaster internally (salt contaminated)
- blocked / broken downpipes - leaking

1. Water penetration:
 - Blocked, broken rainwater pipes /Blocked drains;
 - Leaking parapet gutter linings;
 - Structural steelwork pierced flashings and upstands;Problem - No longer a drainable cavity
2. Soluble salts migration from cementitious grout filled cavity – causing failure of brickwork and the plaster

SOLUTION: Not maintenance....

but a major project and then continue to monitor.

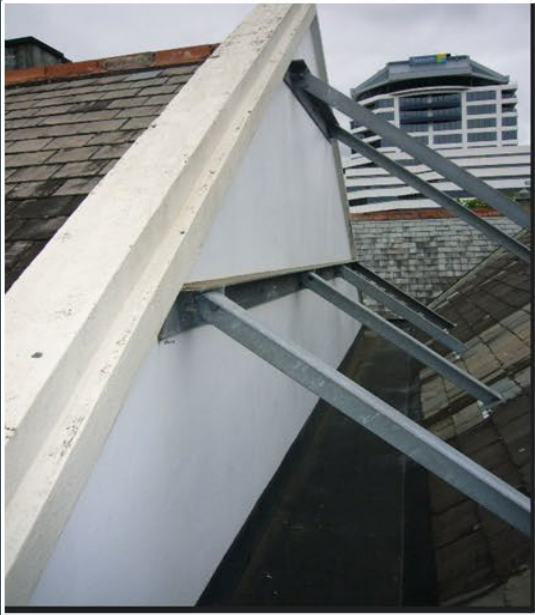
1990s seismic retrofit

Seismic upgrade 15years old – caused major implications for health and maintenance of this building

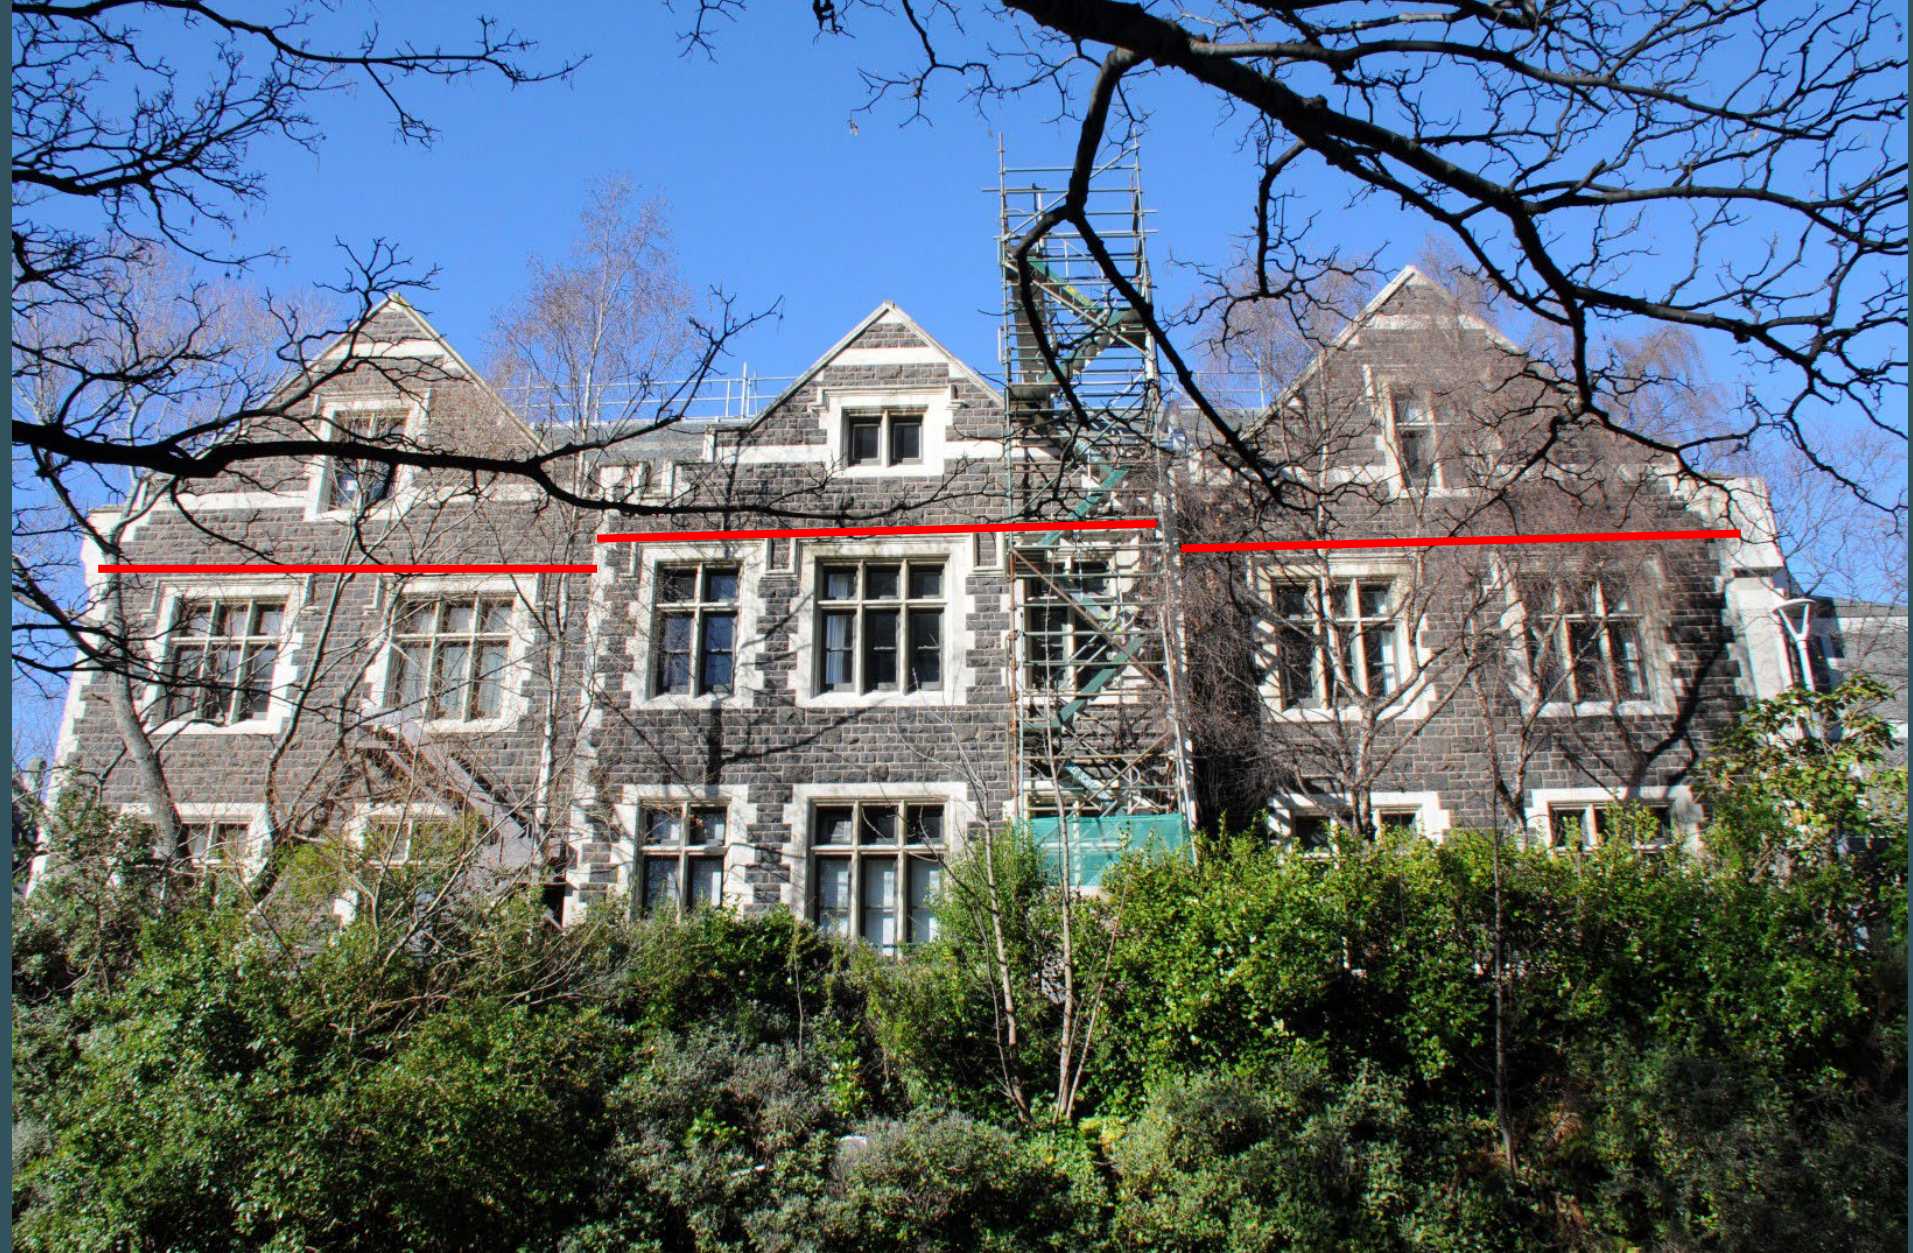
Rebuilding the gable walls - lightweight construction??

- cause significant loss of valuable heritage fabric;
- **be in contravention of policy statement for achieving of min 34%NBS;**
- adversely affect the integrity and authenticity;
- not satisfactorily balance engineering performance with heritage preservation and sustainability;
- result in the upper third of the building, with its most significant architectural features ending up as **skin deep replicas**, that have a shorter renewal period, and so will increase life-cycle costs of the building;
- ultimately devalue the heritage asset

University review alternative structural options between a target of min 34%NBS and 67%NBS seismic resilience, in order to compare the adverse effects on the heritage fabric versus the overall benefits.

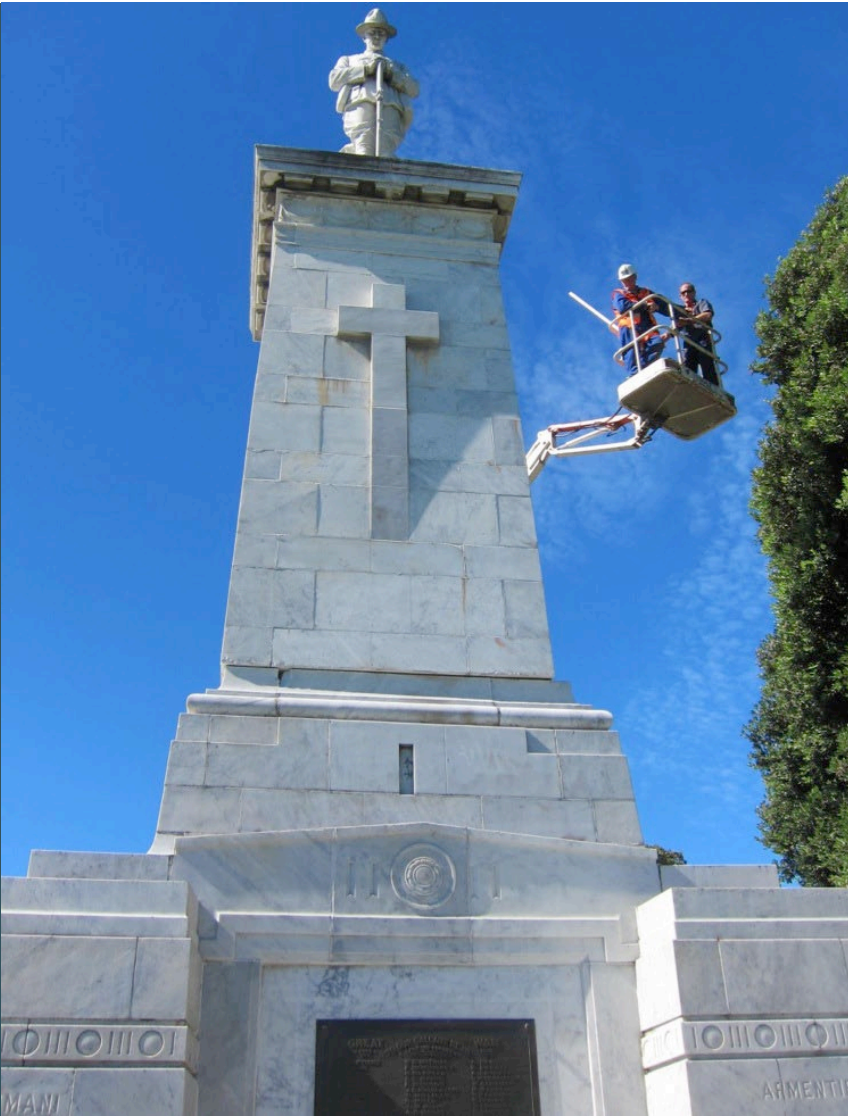
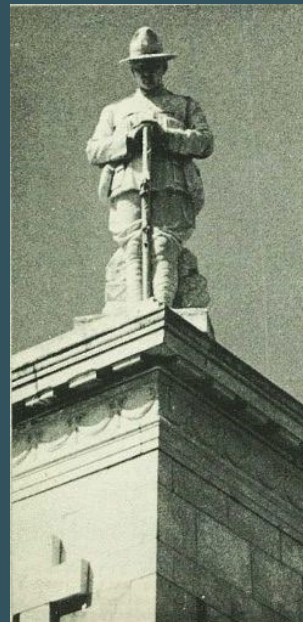
In 2007, an earthquake struck the Gisborne region, causing significant damage to a number of buildings in the central city. The Cenotaph itself was also damaged, with the upper shaft bearing the figure of a soldier dislocated from the base and moved about 65mm to the north-west. This is not the first instance of earthquake effects on the structure – an earlier event resulted in the figure of the soldier being rotated about 45 degrees.

Initial repair proposal being advocated:

Demolish and rebuild – around a new concrete core

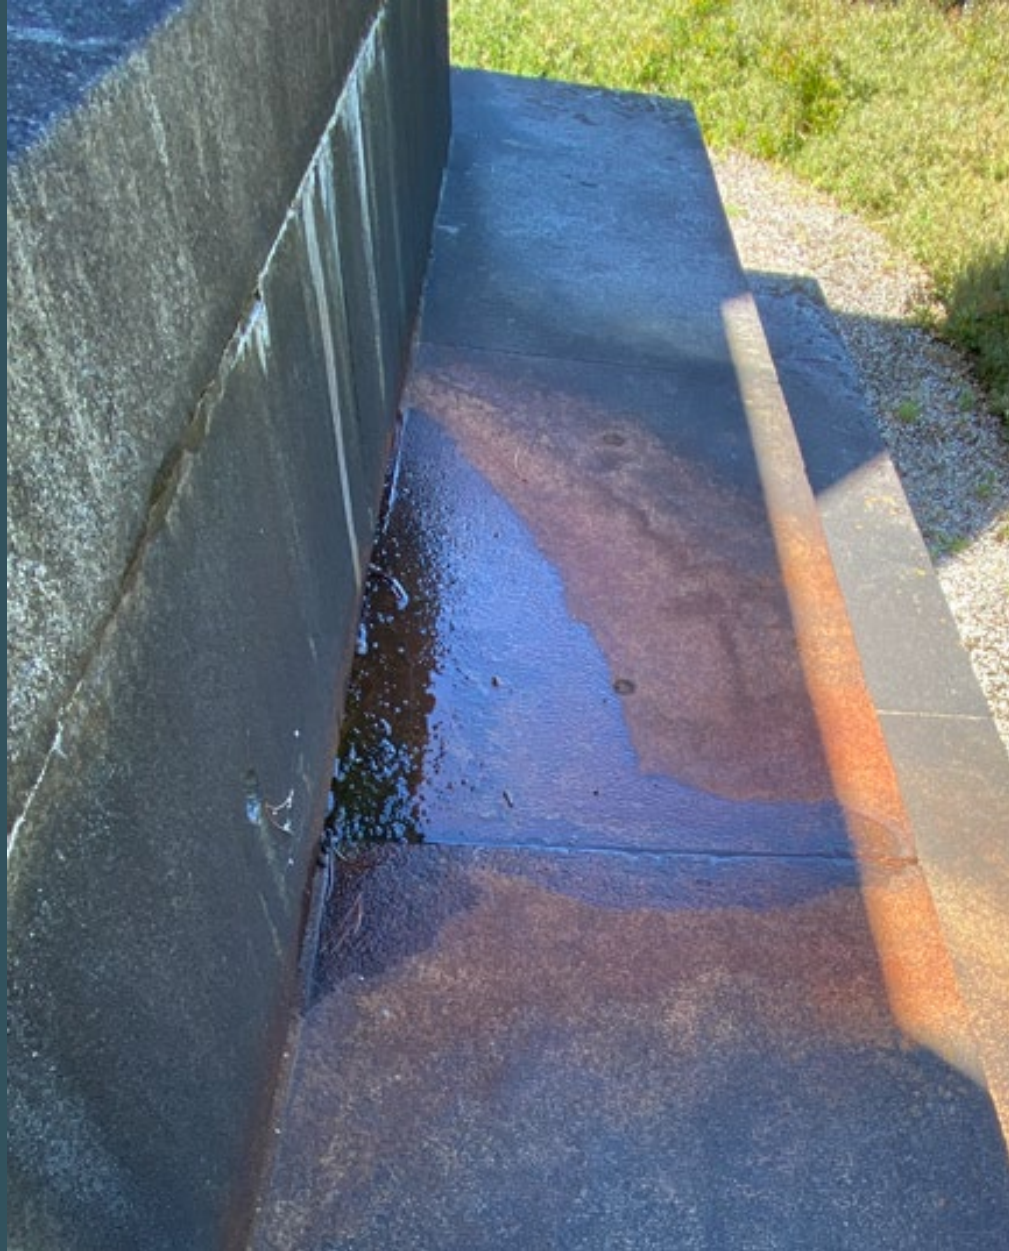
Concerns about condition and water penetration

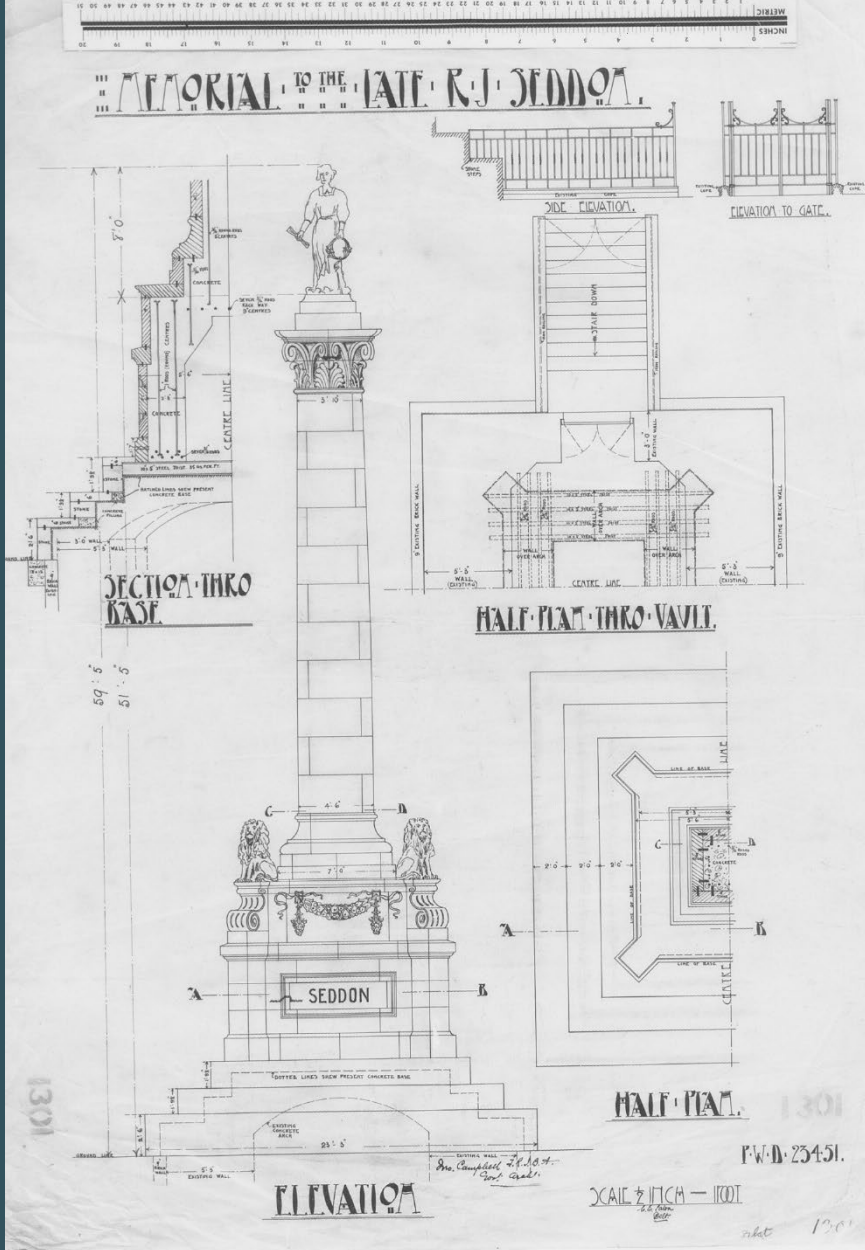
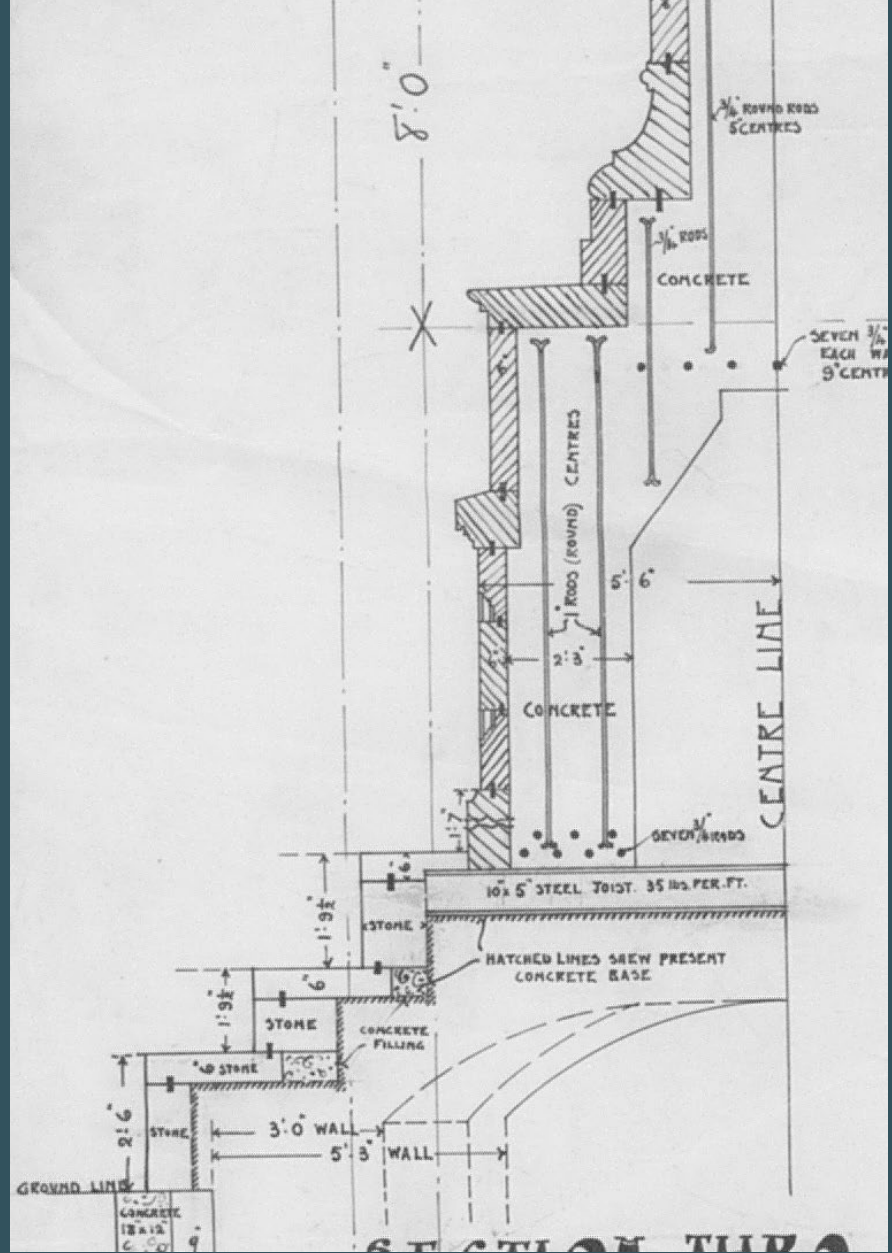
Corrosion staining/water leaching – first noted 1930s

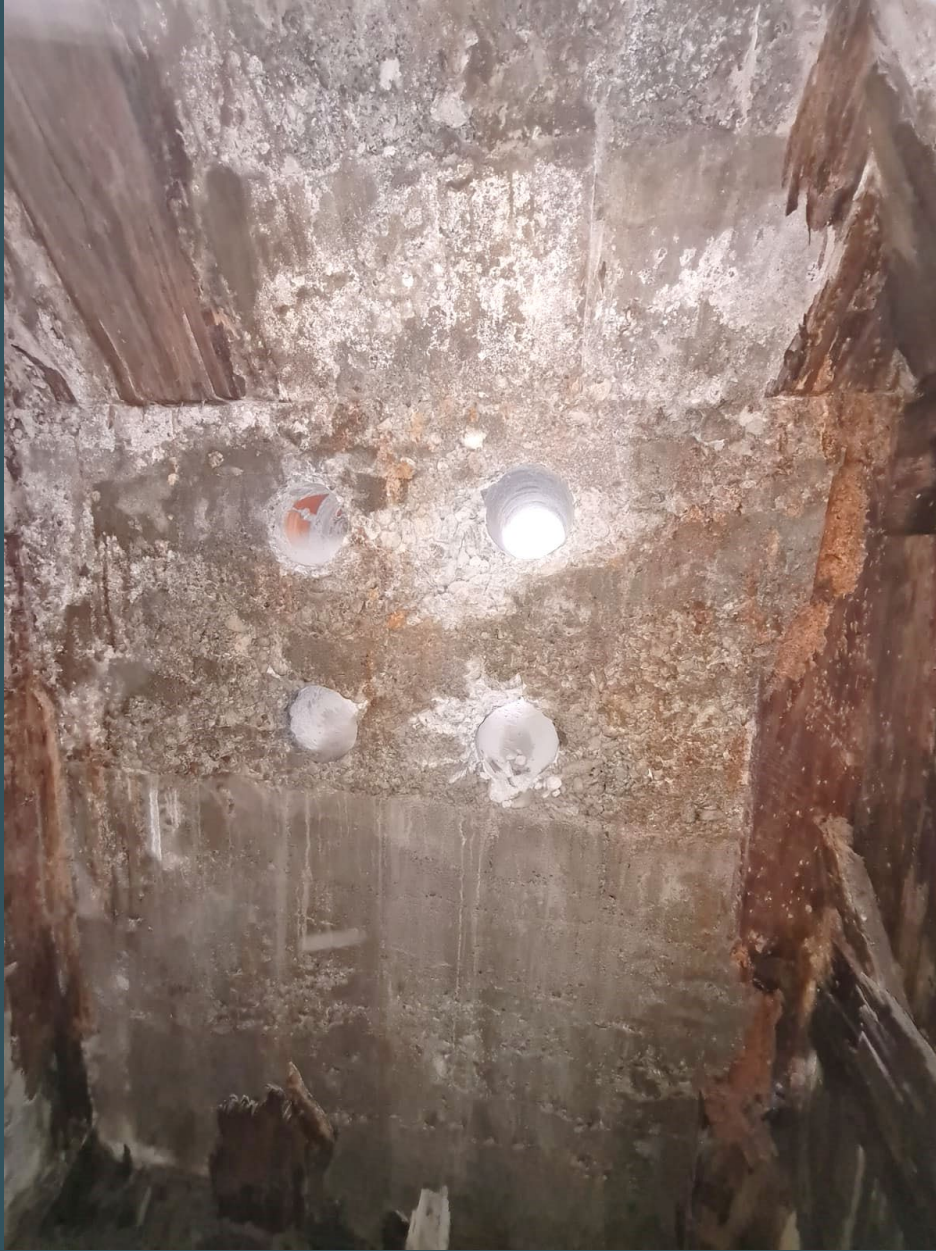
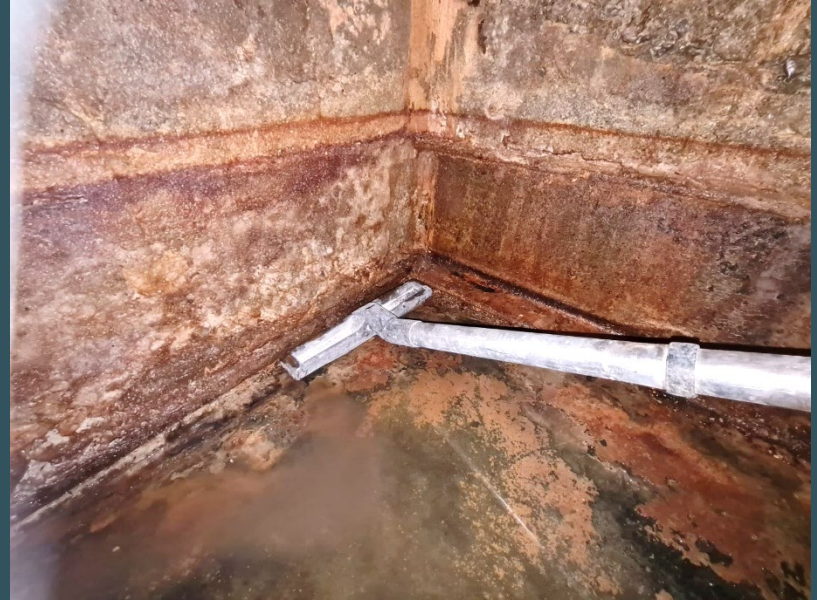
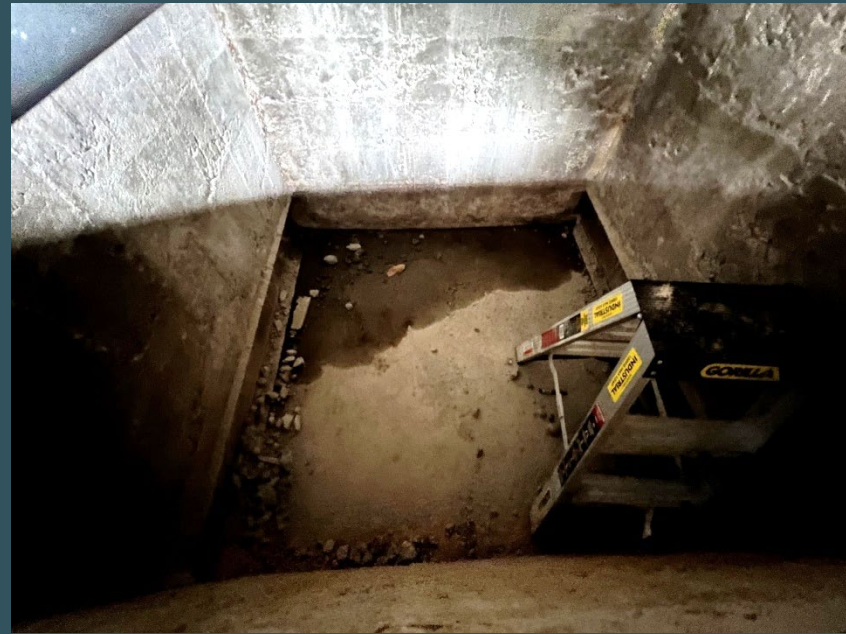
Saturated Void

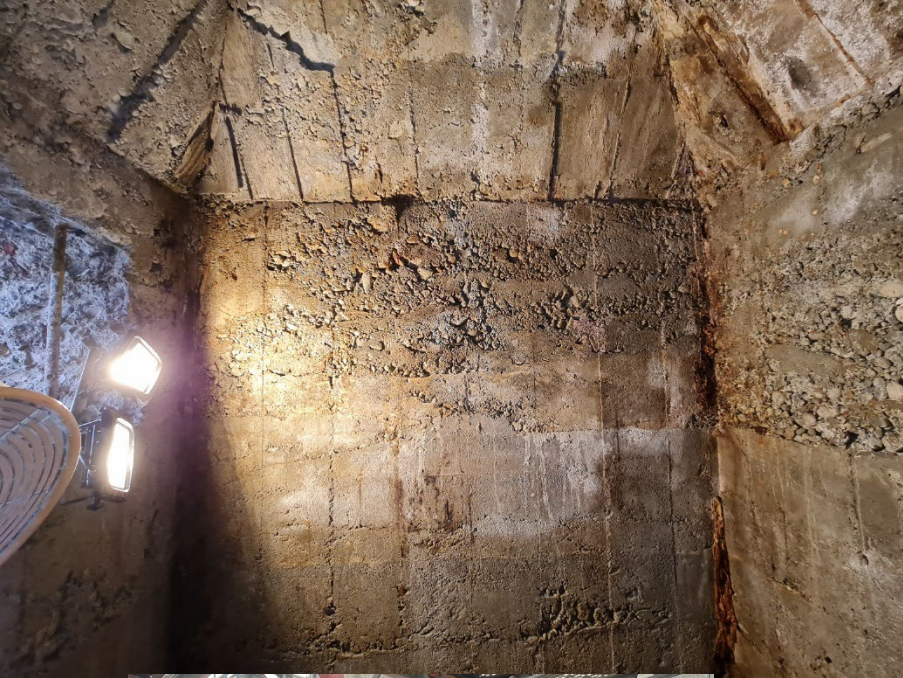
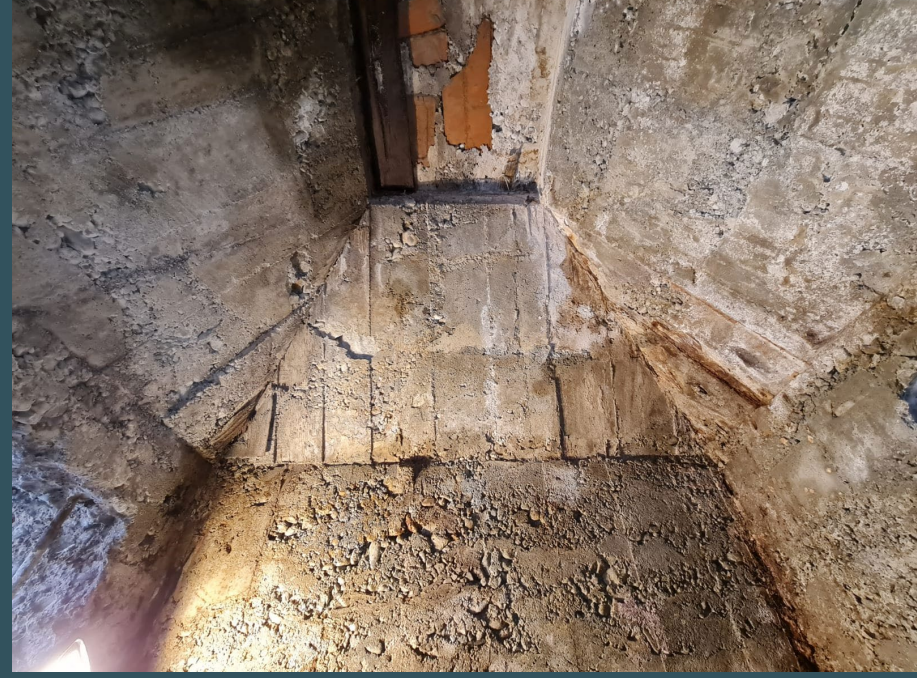
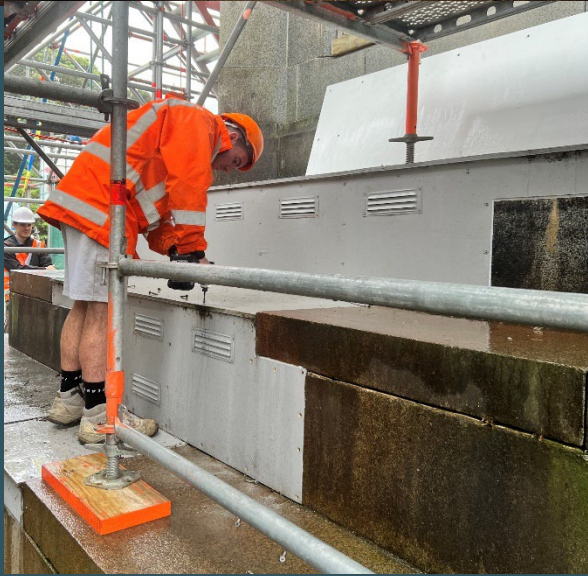
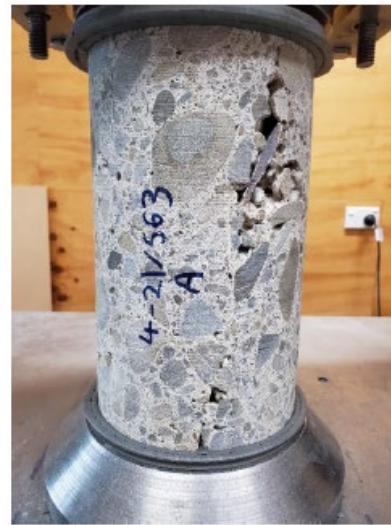
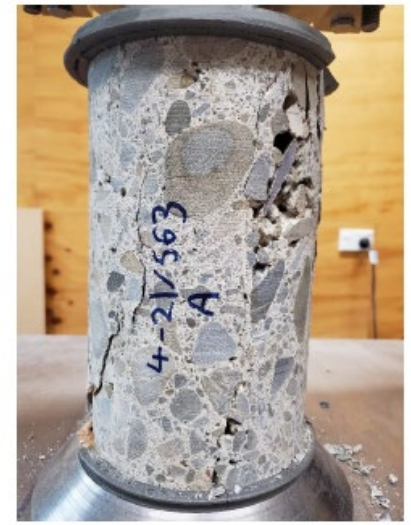
Rotted timber – Tannins causing staining

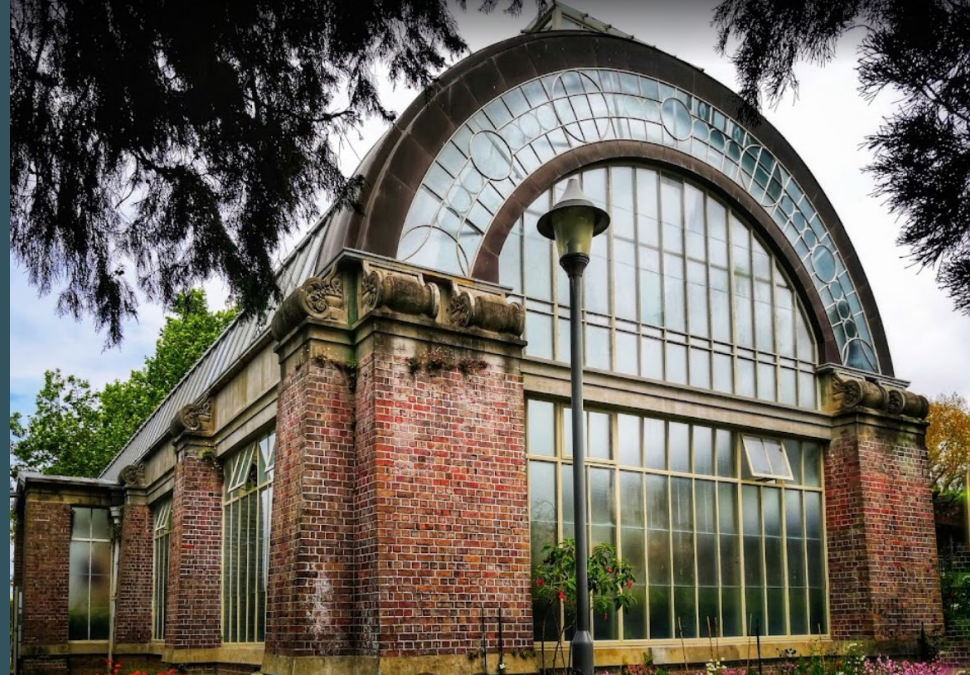
- Walls/piers – 67%NBS;
- Roof system excessively flexible and members insufficiently sized;
- Potential for cracking /shattering of brittle glass to roof – fall hazard;
- Tropical House chimney - potential fall hazard;
- Boiler House roof required a diaphragm;

1. Install diagonal tension bracing to the iron roof structure;
2. Supplement critical iron roof members;
3. Upgrade and underpin the chimney;
4. Add diaphragms to the Boiler House.

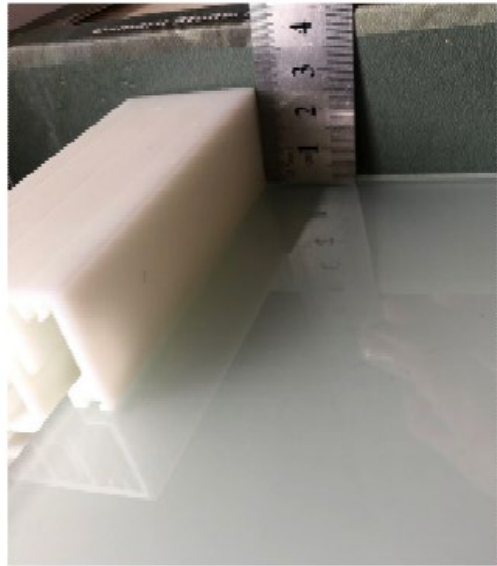
Original Design of New Roof Glazing bar with gasket

Original standard glazing 38mm high above glass

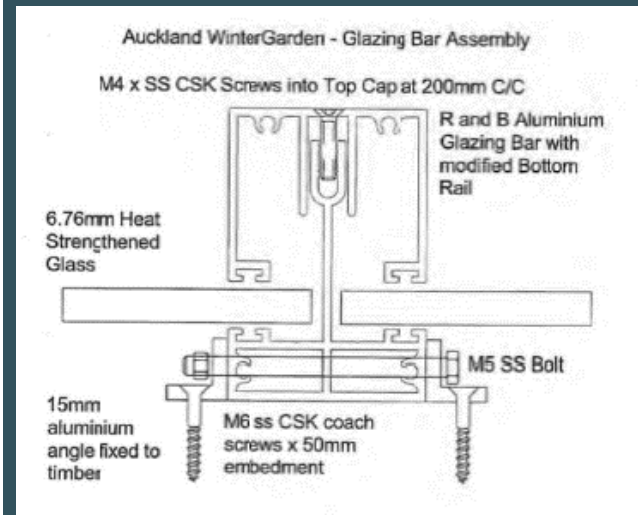
New Roof Glazing bar – note gasket missing

Redesigned to reduce the height of the bar by 8mm
