2022 JOINT CONFERENCE OF HISTORIC PLACES NEW AOTEAROA AND ICOMOS NZ

THE ENGINEER'S VIEWPOINT

TIAGO ALMEIDA
(BACKBONE STRUCTURES)

12th NOVEMBER 2022

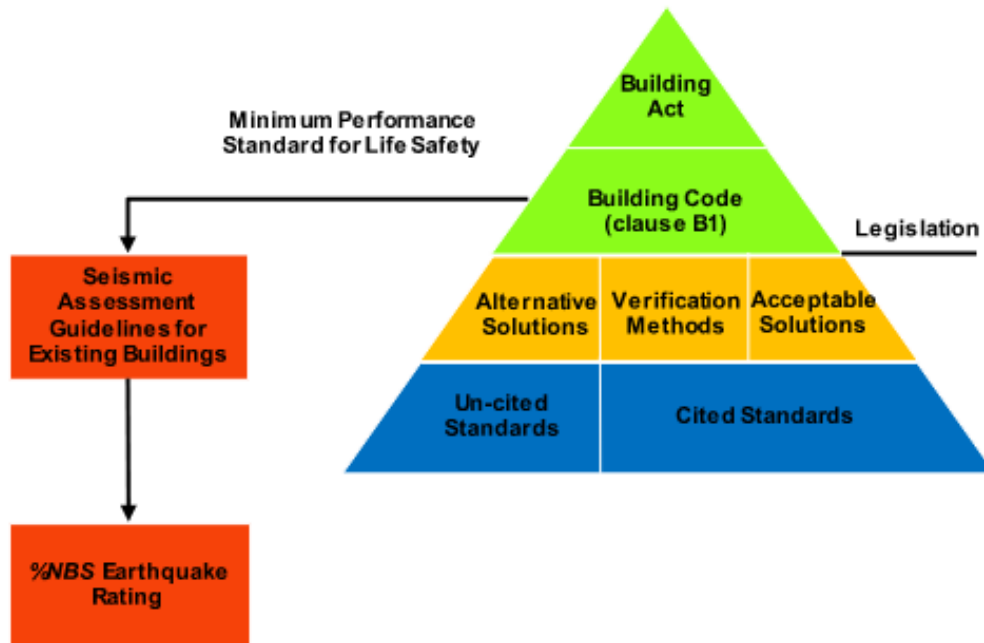
Figure A3.1: Relationship between Clause B1 of the Building Code and Earthquake Rating

%NBS = Percentage of the new building standard that applies to an equivalent building on the same site

$$\%NBS = \frac{\text{Ultimate capacity (seismic)} \times 100}{\text{ULS seismic demand}}$$

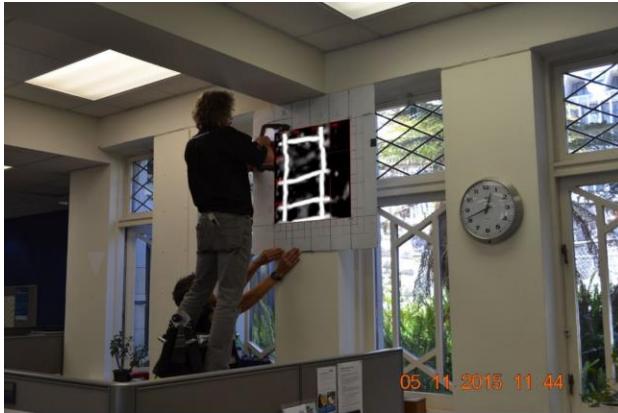
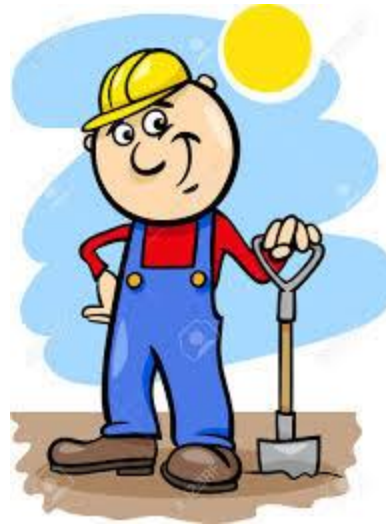
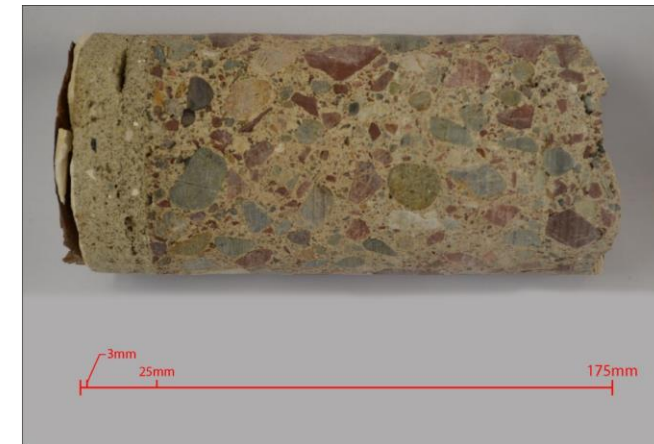
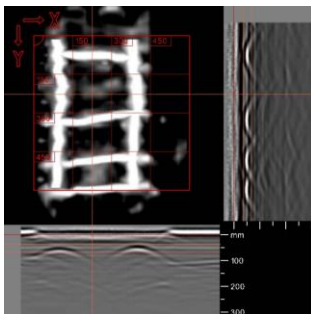
- Careful information gathering and investigations

Don't be surprised you will find surprises!!!

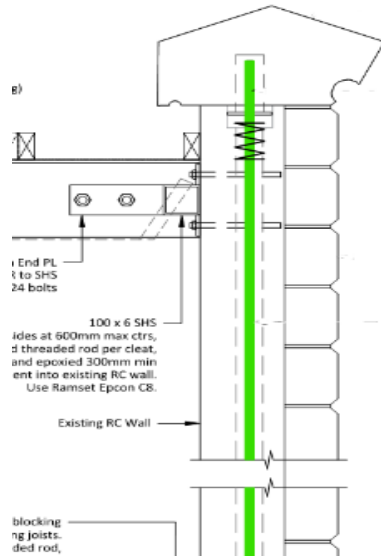
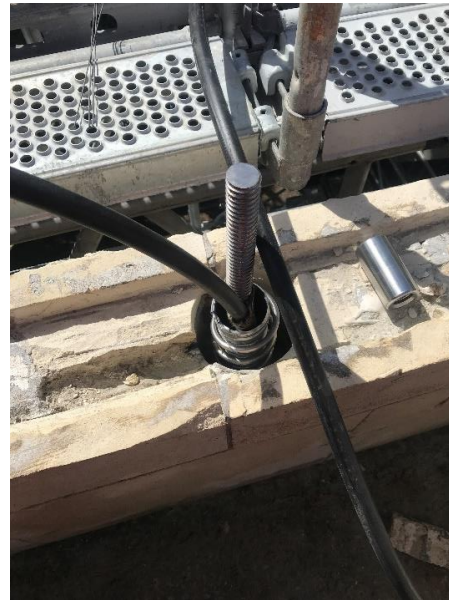
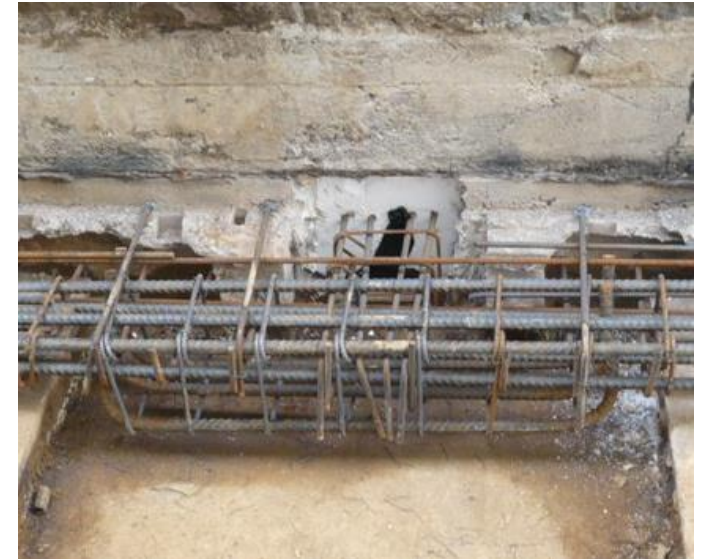
THE FORMER ARTS BUILDING AT UoA

STRENGTHENING WITH POST-TENSIONED BARS

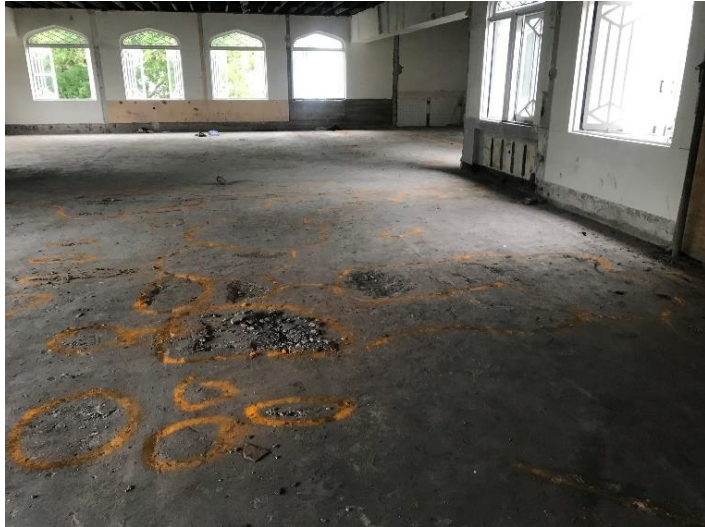
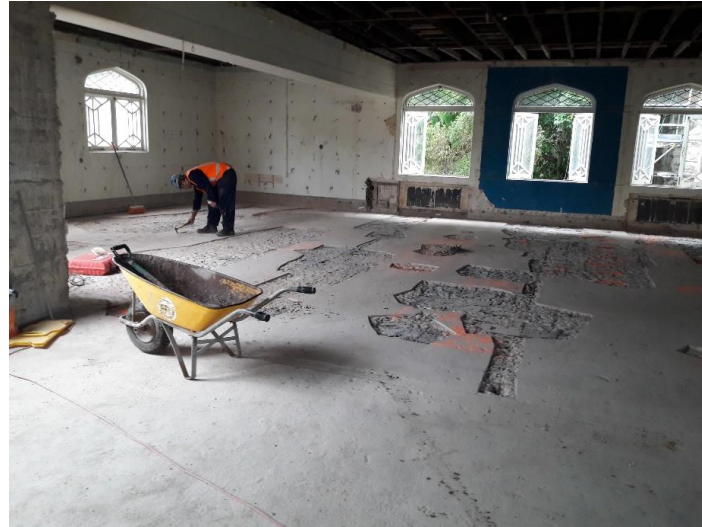
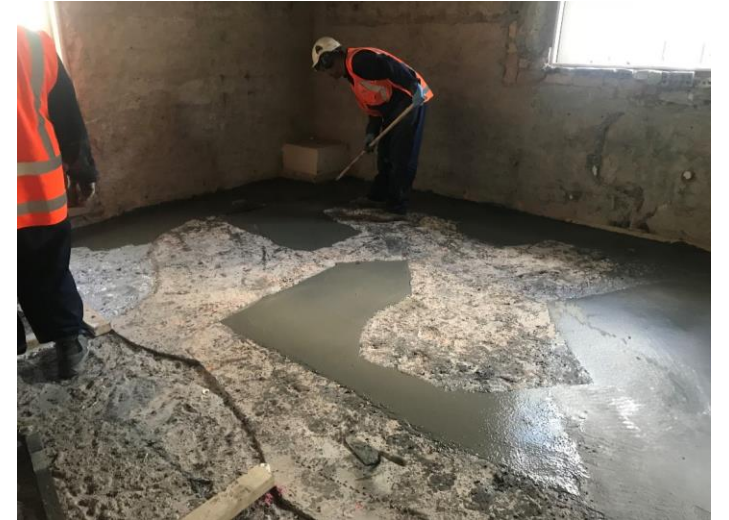
THE FORMER ARTS BUILDING AT UoA

STRENGTHENING WITH FRP SYSTEM

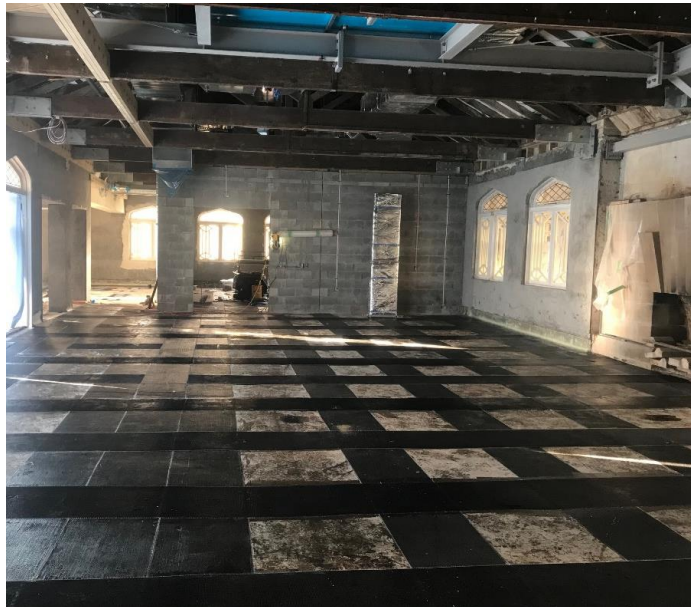
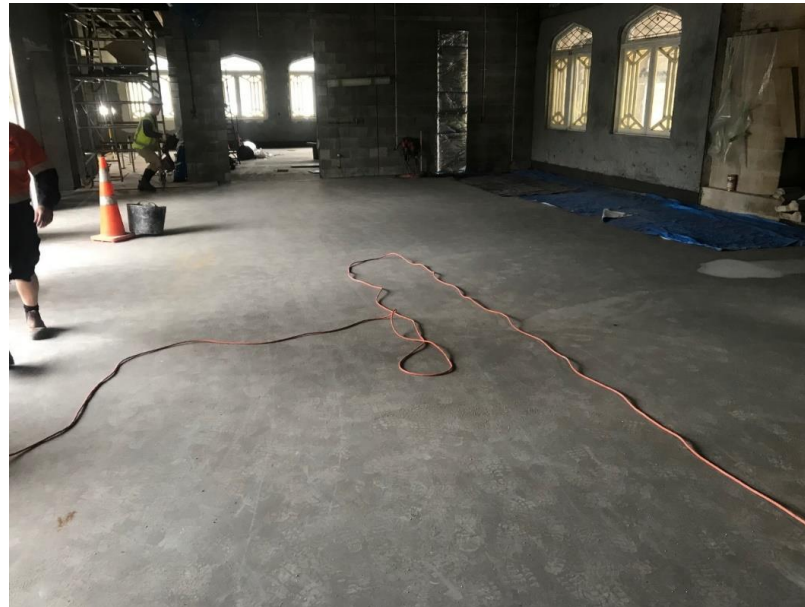
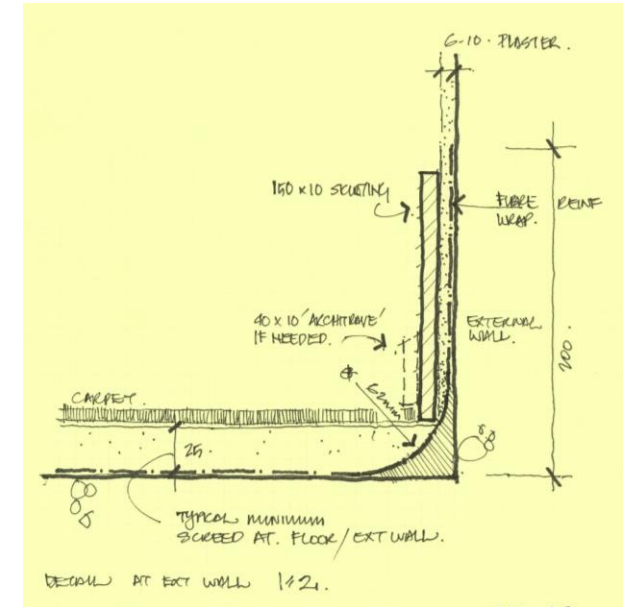
THE FORMER ARTS BUILDING AT UoA

STRENGTHENING WITH FRP SYSTEM
