ICOMOS New Zealand and
Historic Places Aotearoa Conference
12 November 2022

SEISMIC RESILIENCE – CHALLENGES FOR BUILT HERITAGE
CASE STUDIES

Tracey Hartley, Senior Associate – Salmond Reed Architects

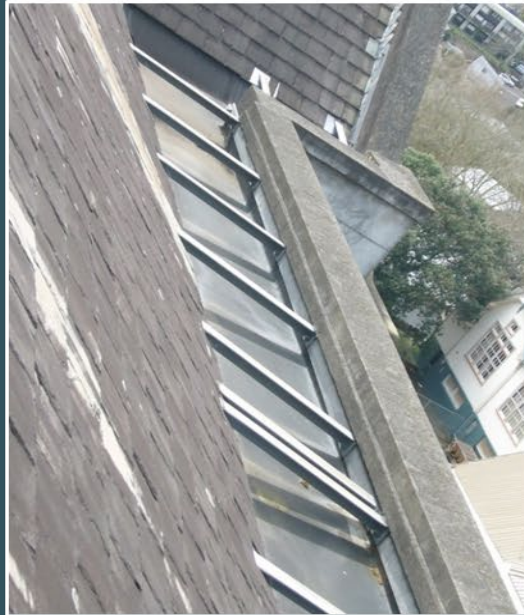
Structural steel fitted at flashing /upstands level

1. Water penetration:
 - Blocked, broken rainwater pipes /Blocked drains;
 - Leaking parapet gutter linings;
 - Structural steelwork pierced flashings and upstands;Problem - No longer a drainable cavity
2. Soluble salts migration from cementitious grout filled cavity – causing failure of brickwork and the plaster

SOLUTION: Not maintenance....

but a major project and then continue to monitor.

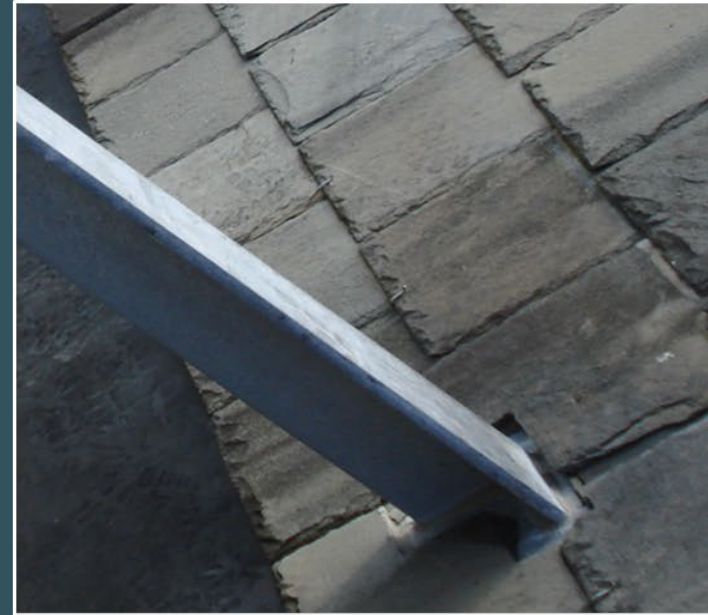
52 penetrations to slate roof reliant on sealant

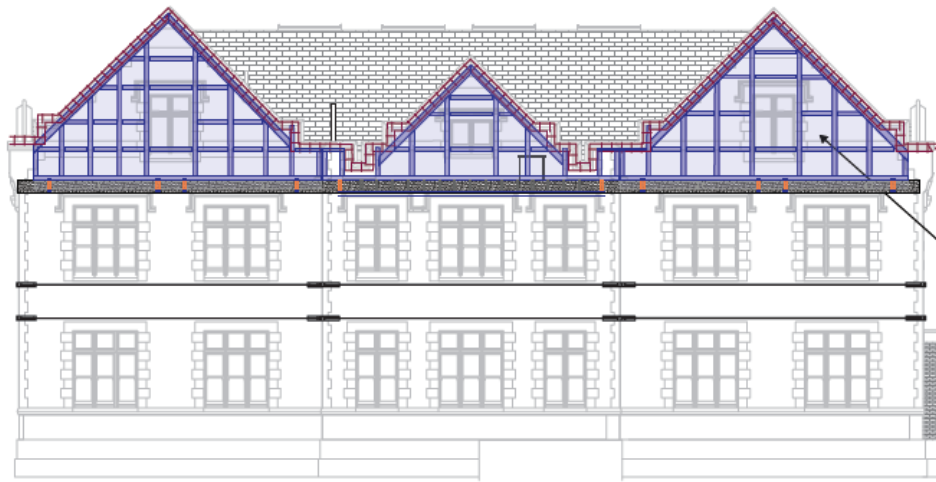
West Elevation

- Dismantling all stone gable walls including windows
- New concrete ring beam
- Grouting of soft fill to the solid masonry walls (stone /brick)
- Rebuilding the gable walls - lightweight construction
- Removal of internal of timber walls replace with concrete
- External post tensioning
- Partial underpinning

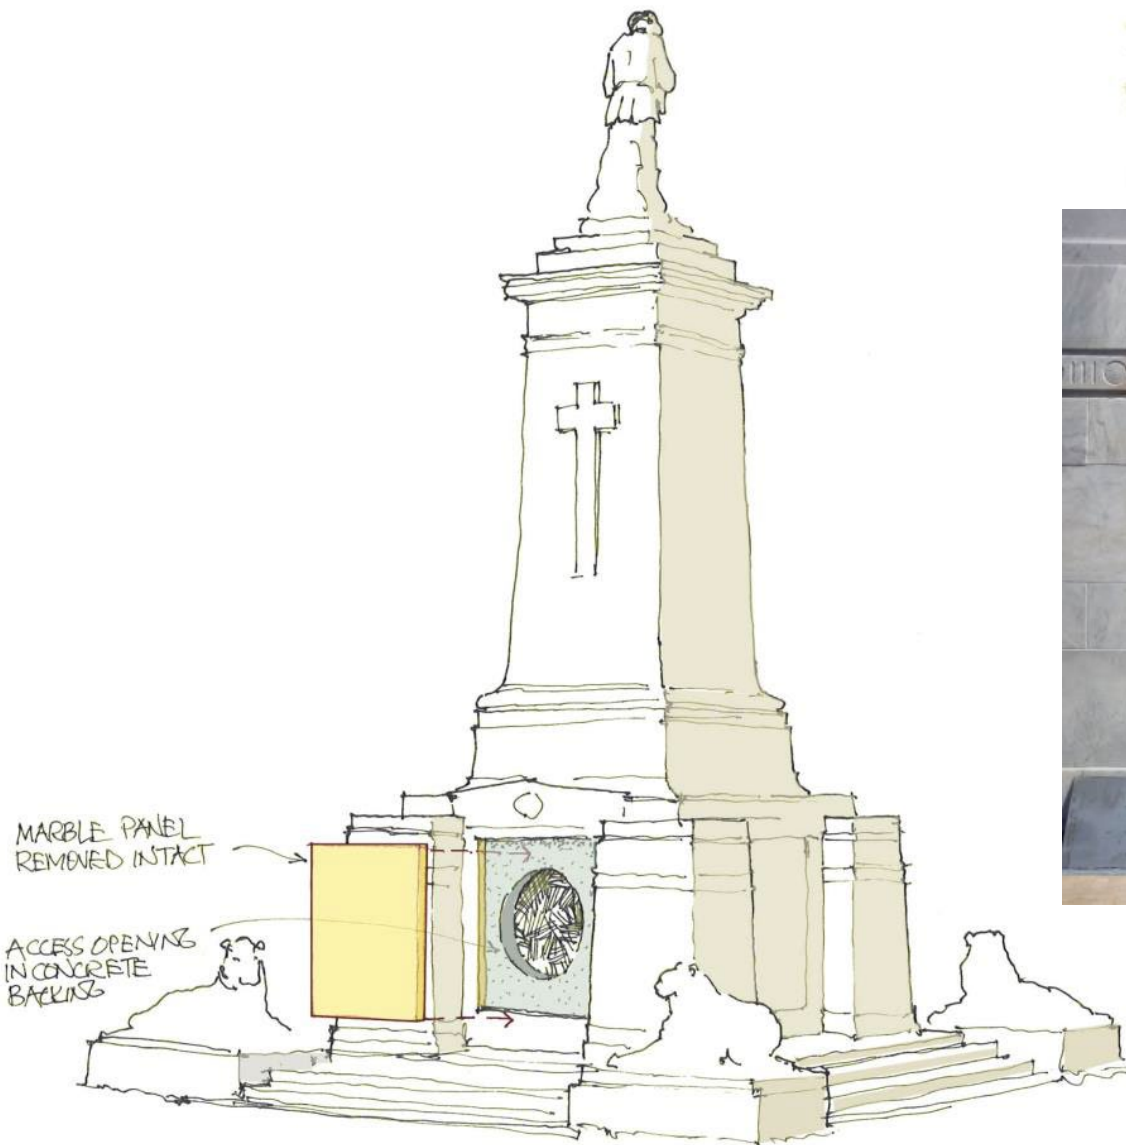
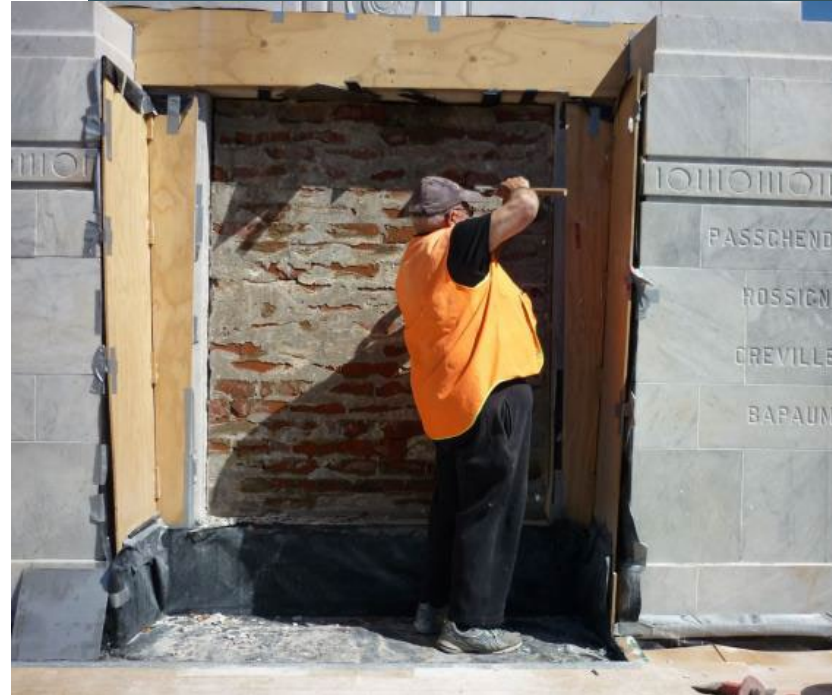
In 2007, an earthquake struck the Gisborne region, causing significant damage to a number of buildings in the central city. The Cenotaph itself was also damaged, with the upper shaft bearing the figure of a soldier dislocated from the base and moved about 65mm to the north-west. This is not the first instance of earthquake effects on the structure – an earlier event resulted in the figure of the soldier being rotated about 45 degrees.

Demolish and rebuild – around a new concrete core

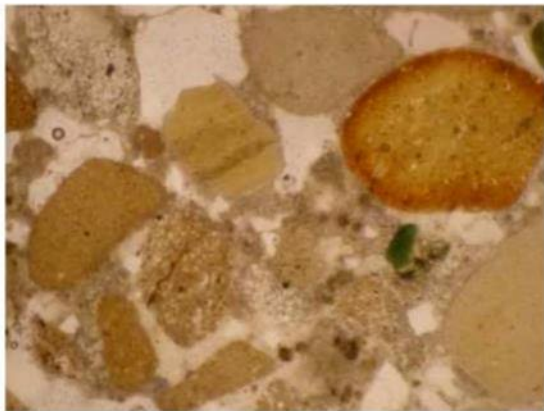
Figure 1: Photomicrograph, typical field of view of concrete from interior of Gisborne Cenotaph, showing fine aggregate particles of calcareous and other mudstone set in limey paste (higher relief, pale grey). Note oxidised rim to clast at top left. Colourless areas have lost friable paste during specimen preparation. Transmitted light. Scale: width of view is 6 mm.

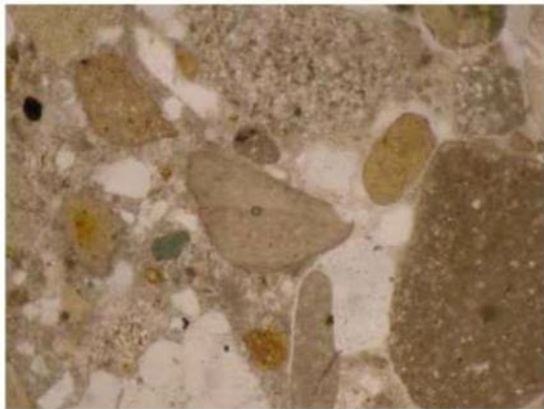
Figure 1: Photomicrograph, typical field of view of concrete from interior of Gisborne Cenotaph, showing fine aggregate particles of calcareous and other mudstone set in limey paste (higher relief, pale grey). Colourless particles are volcanic quartz and molluscan shelly material. Transmitted light. Scale: width of view is 6 mm.

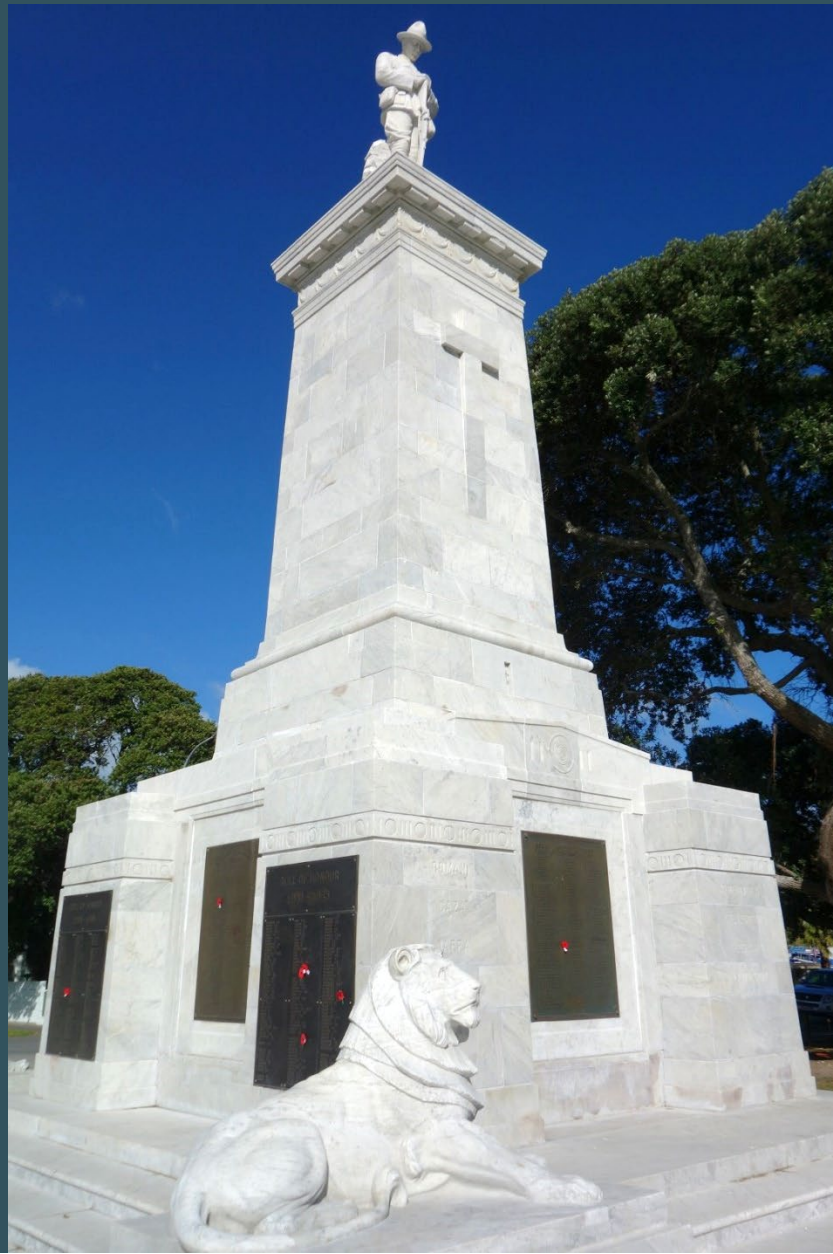
Lifting and Repositioning the Shaft

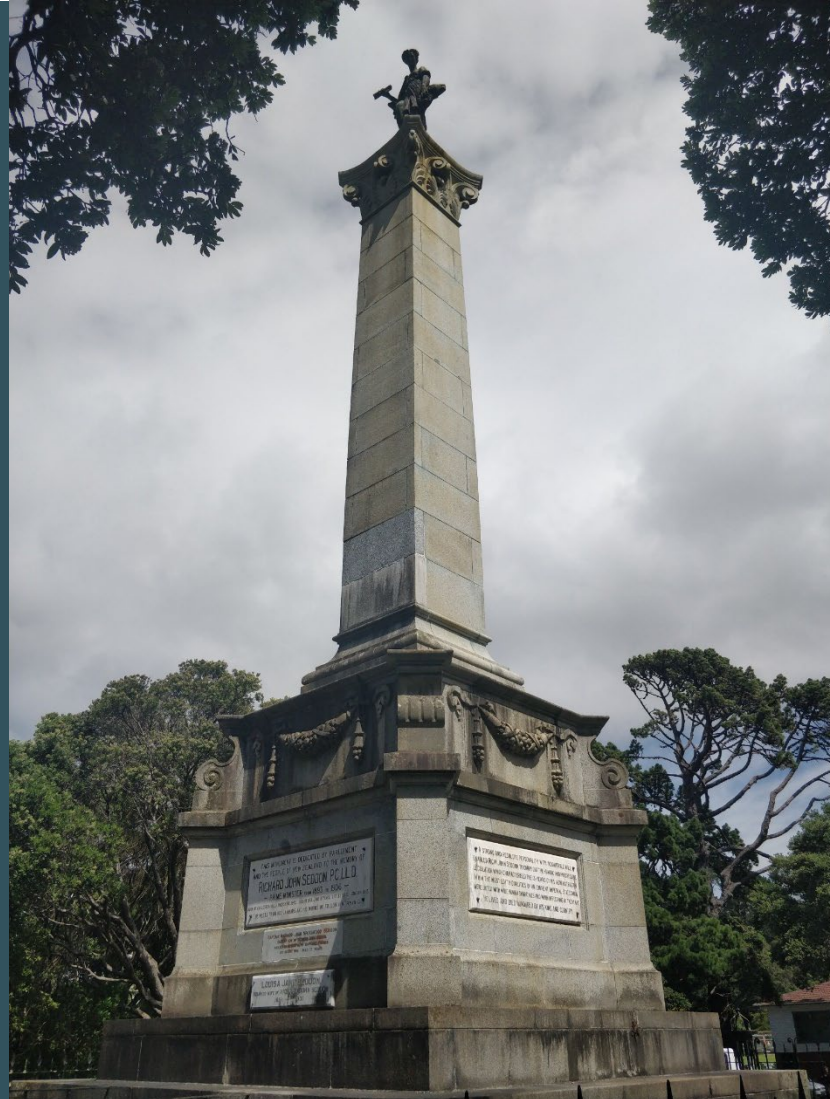
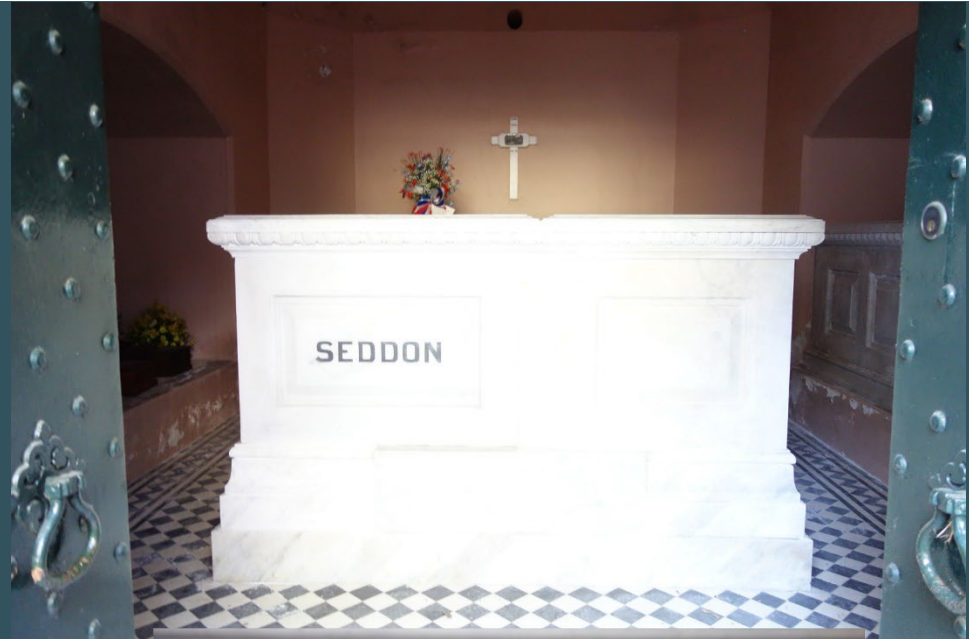
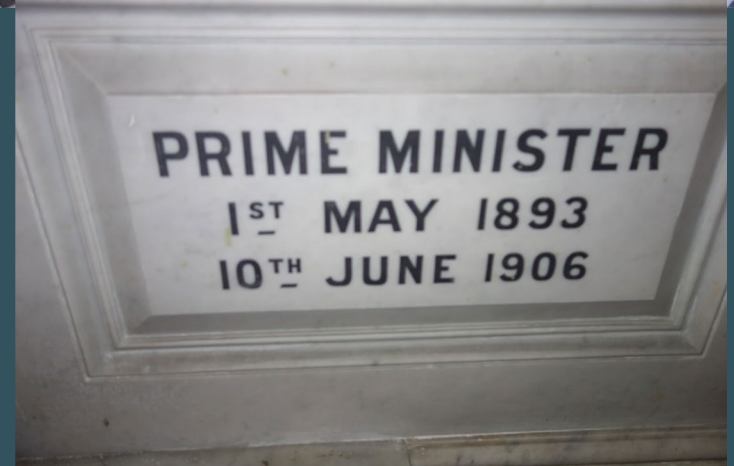
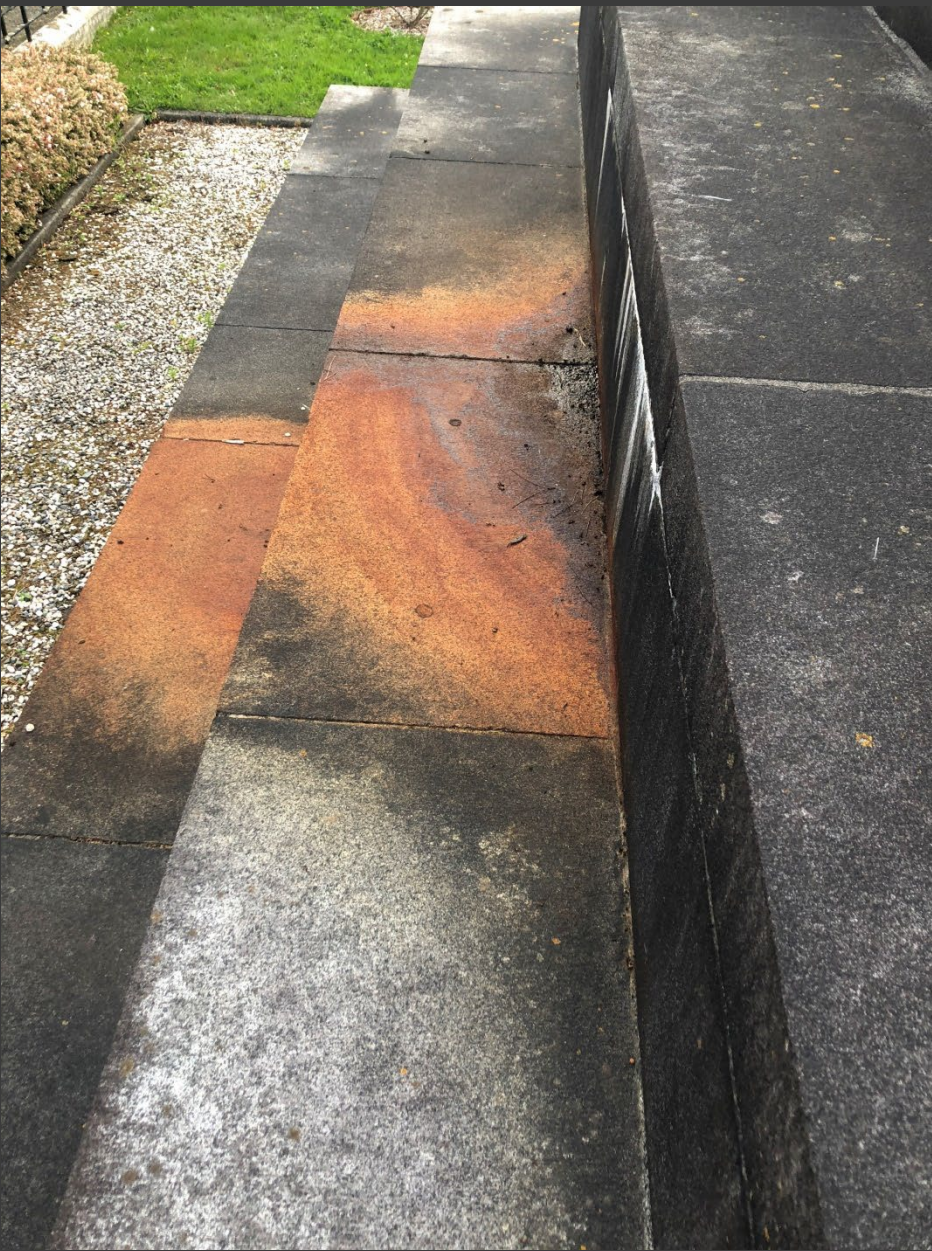
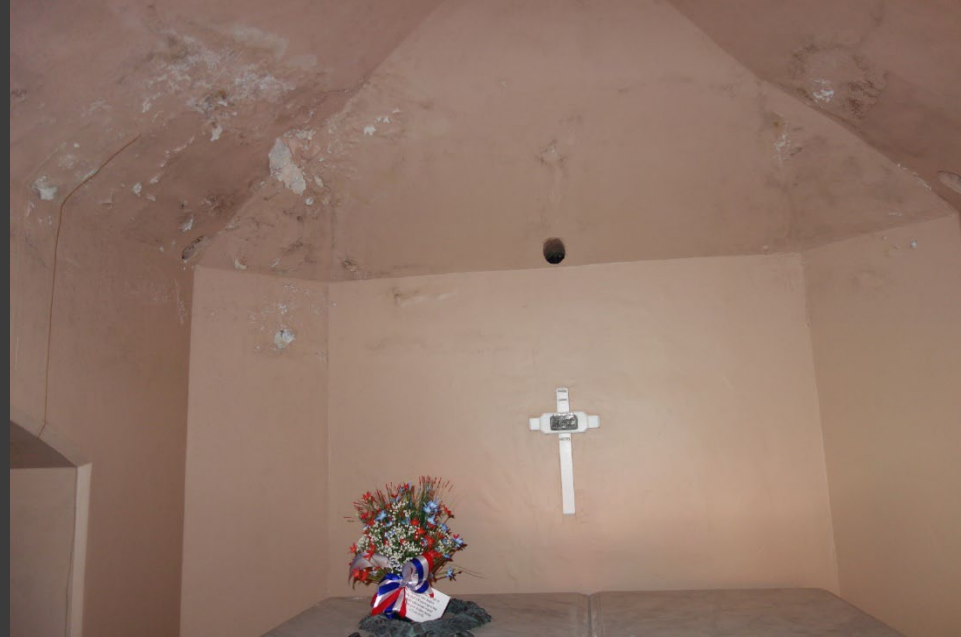
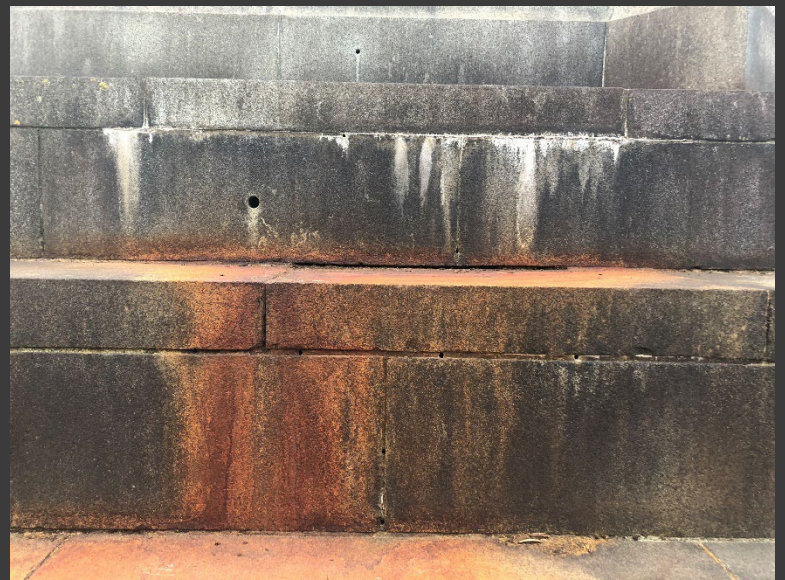
Repairs and maintenance **triggering upgrading**

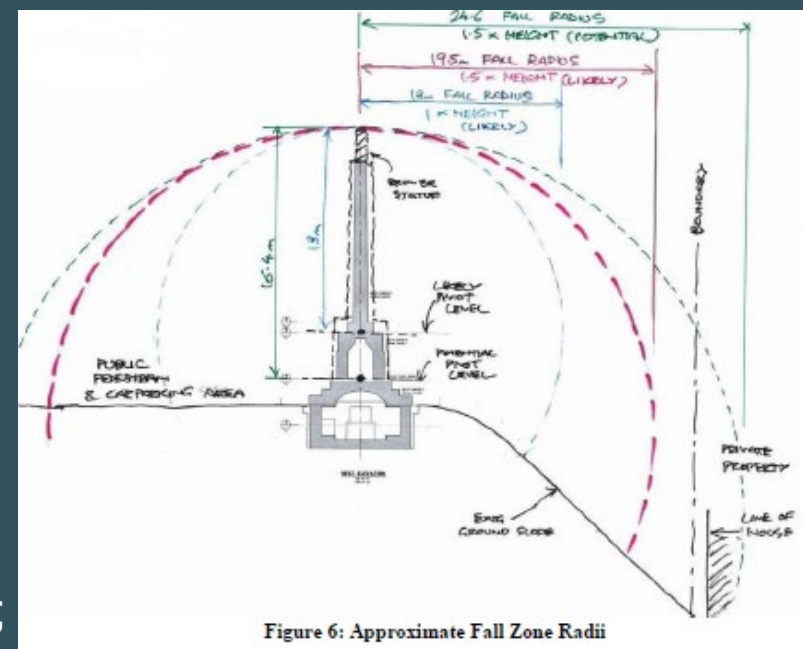
Figure 6: Approximate Fall Zone Radii

- Statue potential for toppling;
- Column anchorage to plinth 15% (Critical);
- Column bending capacity 25%;
- Column pedestal overturning resistance 30%;
- Crypt overturning resistance 100%;

Classified - very high risk

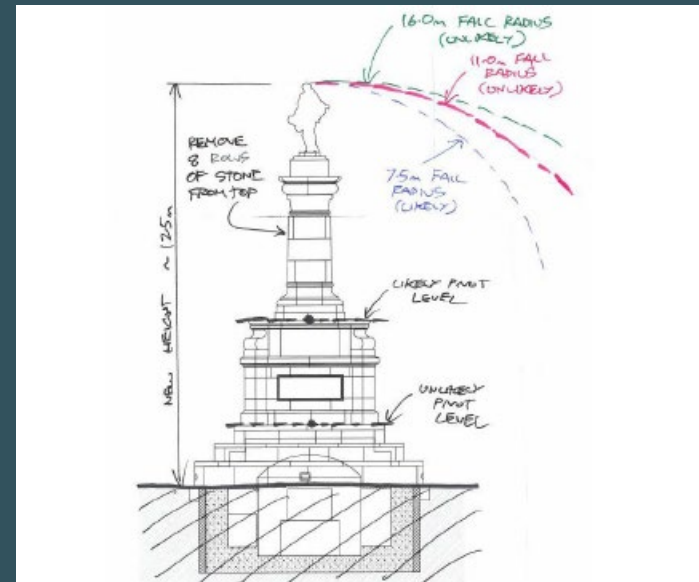
Figure 8 (Left): Reduced likely fall radius range to 7.5-11.0m, seismic rating 38%NBS(IL2)

Reduction in height to 12.5m - 38%NBS

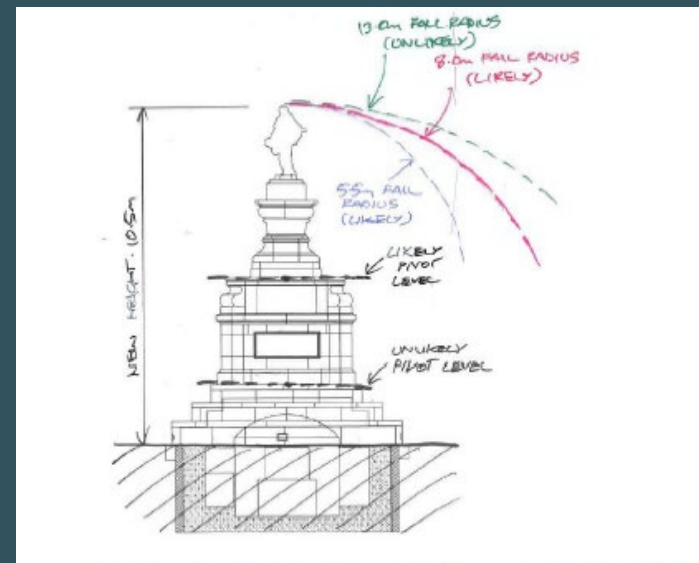
Figure 9 (Right): Reduced likely fall radius range to 5.5-8.0m, seismic rating >100%NBS(IL2)

Reduction in height to 10.5m - 100%NBS

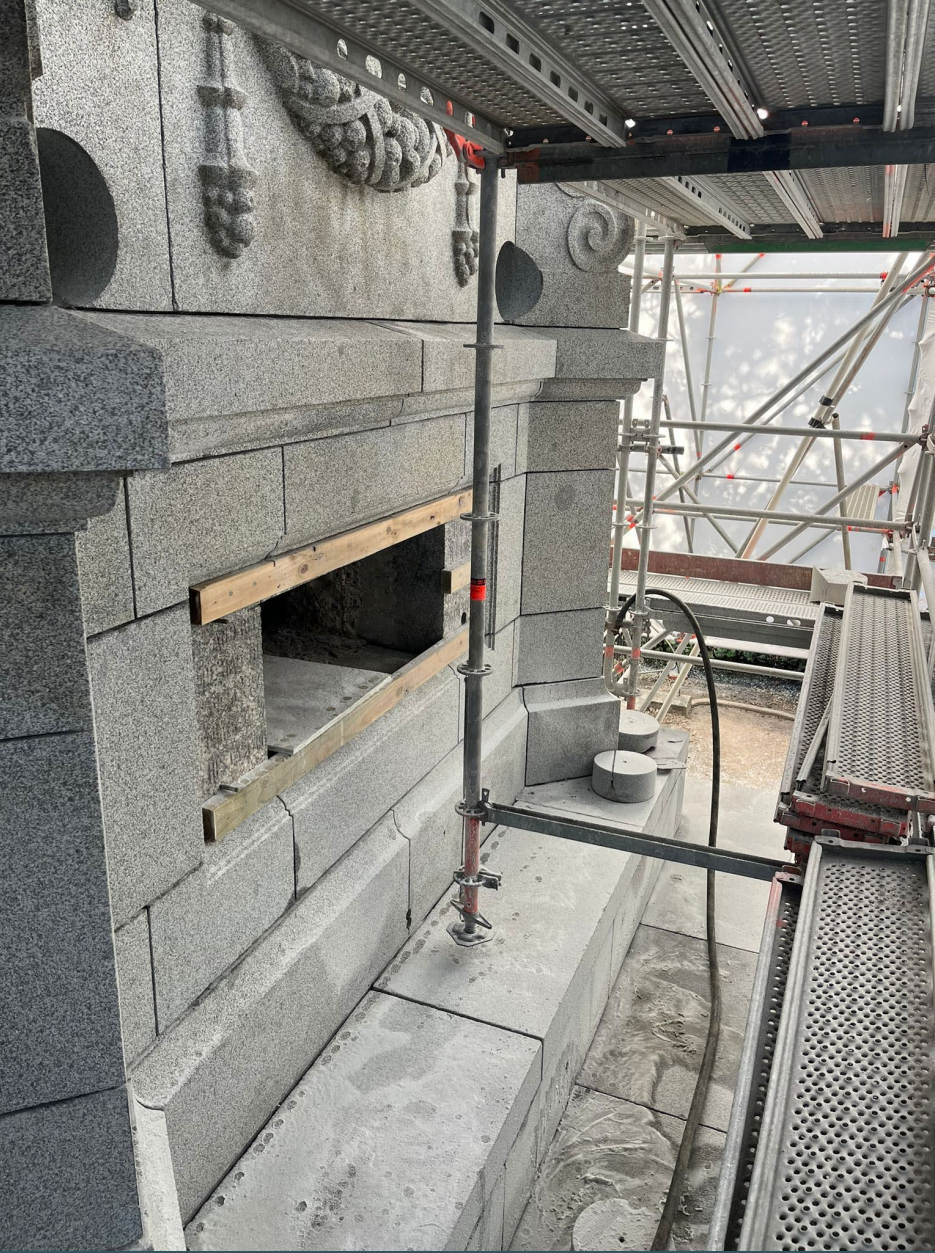
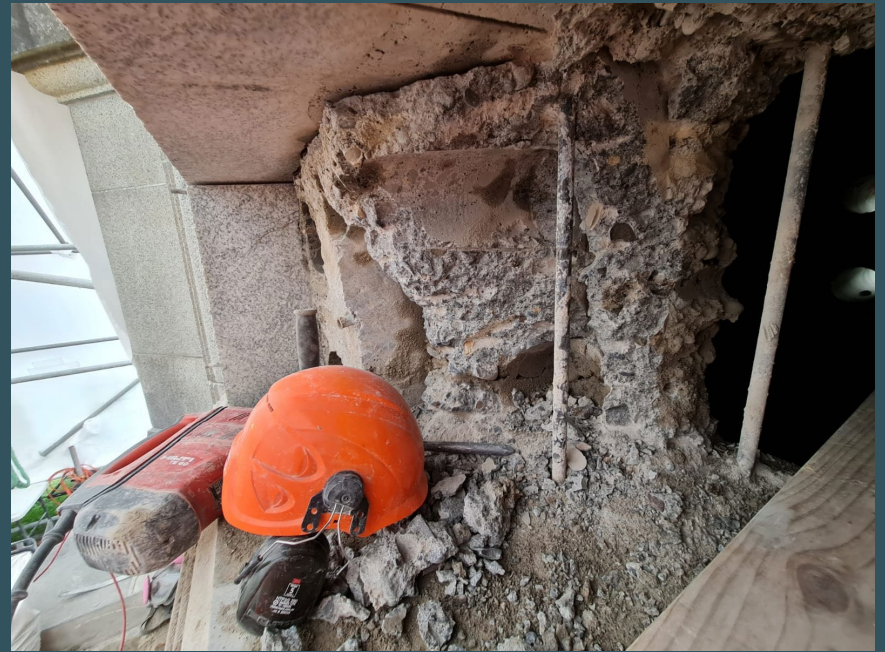
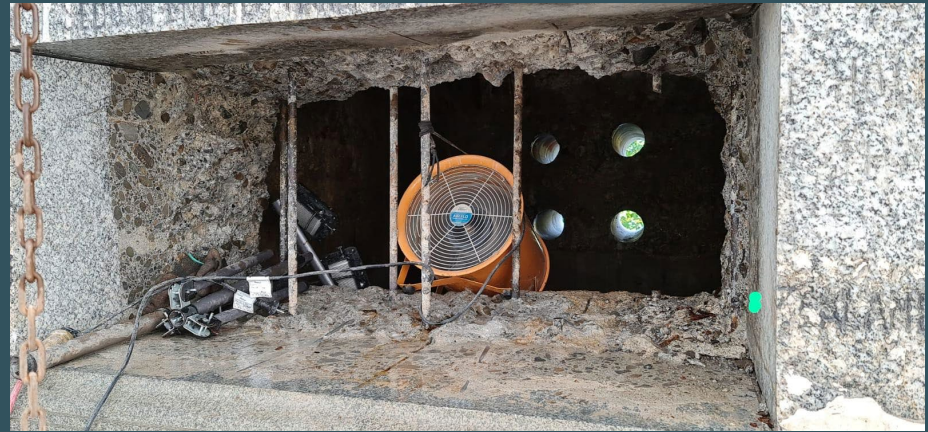
Investigating the corrosion

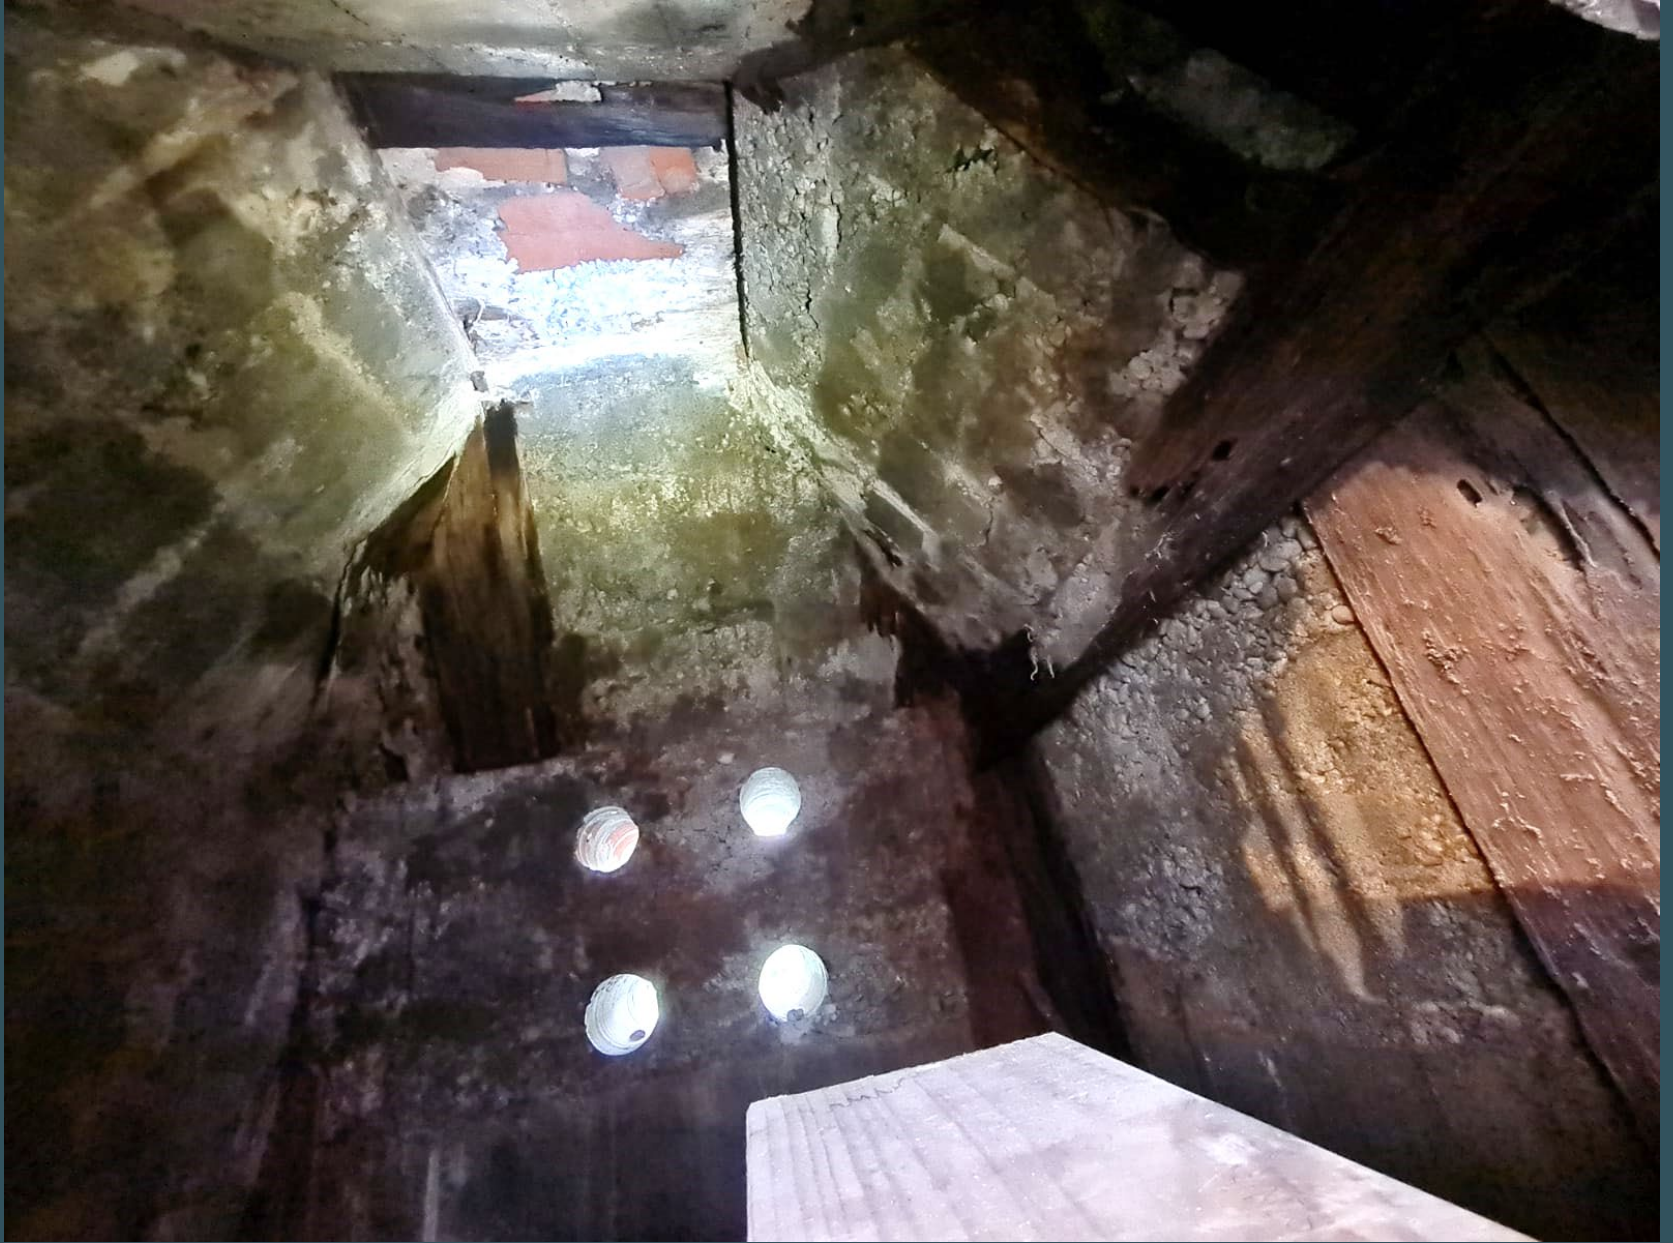
Breaking through to the void

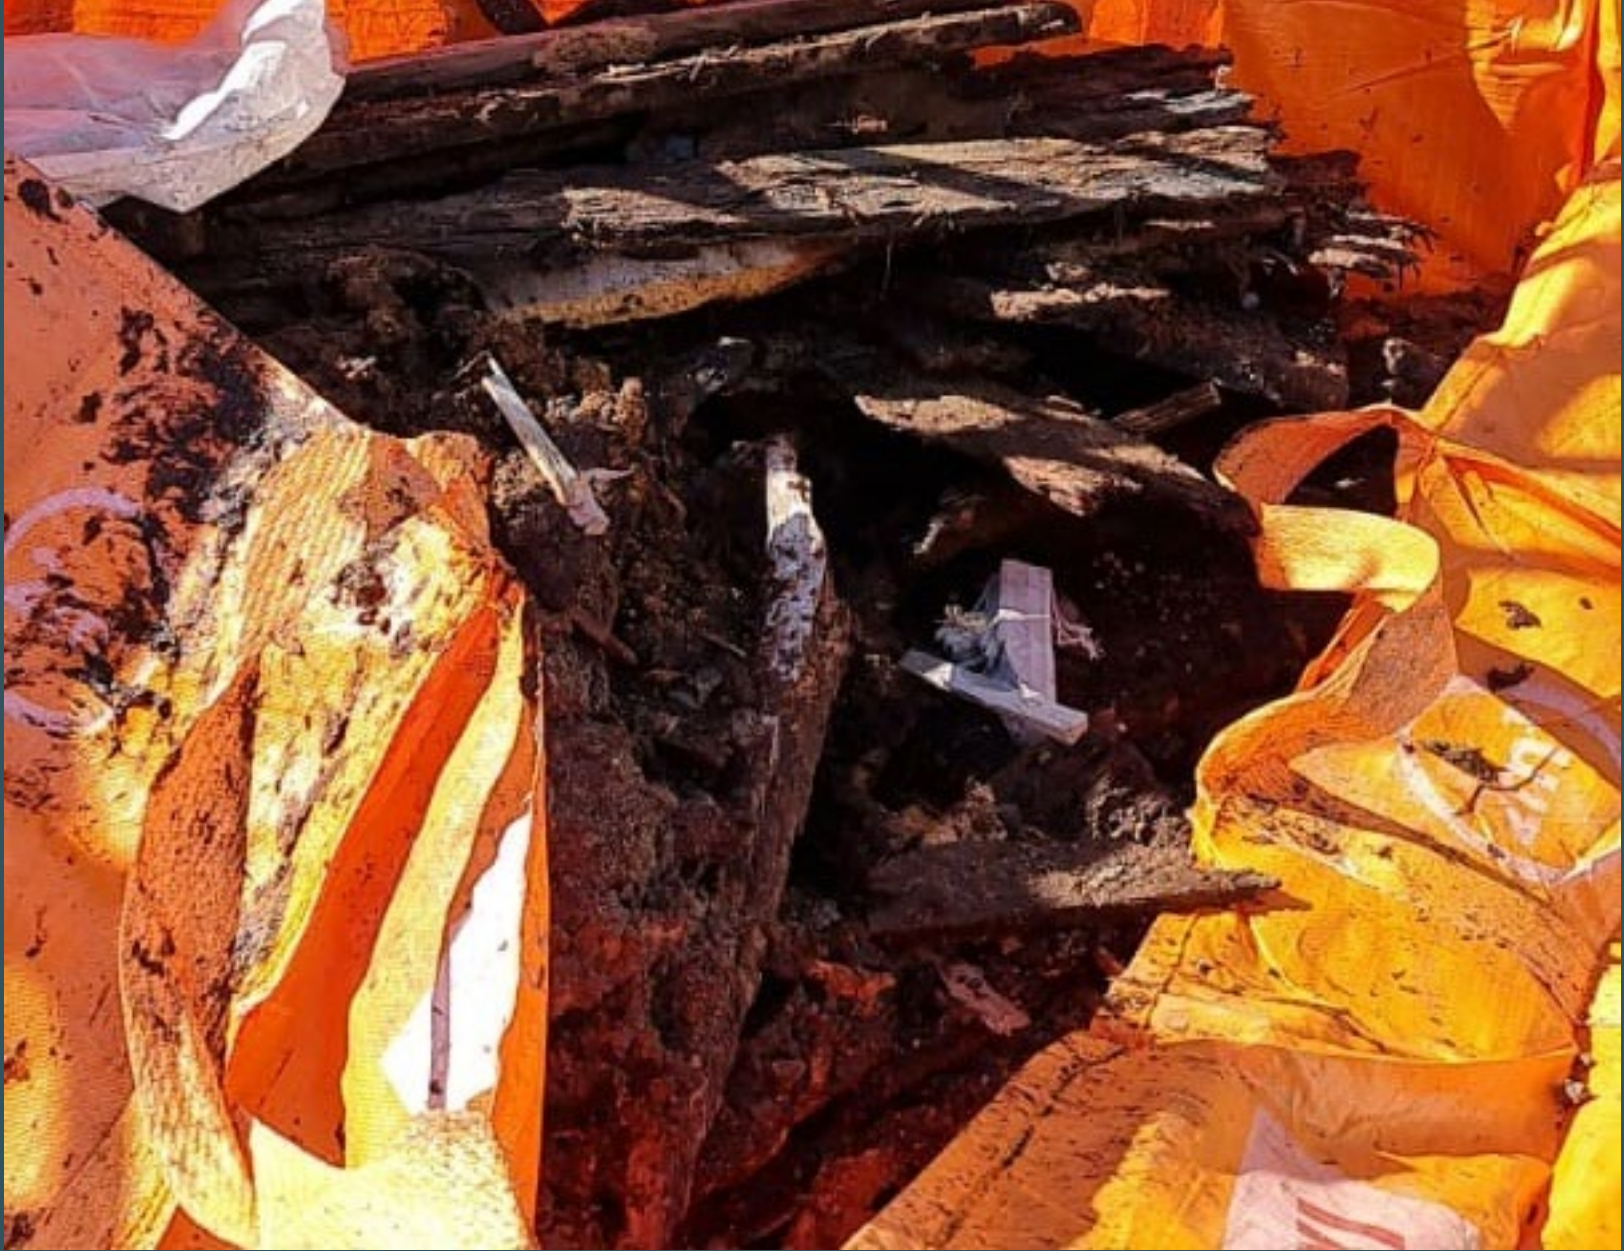
Corrosion ? Never assume anything!

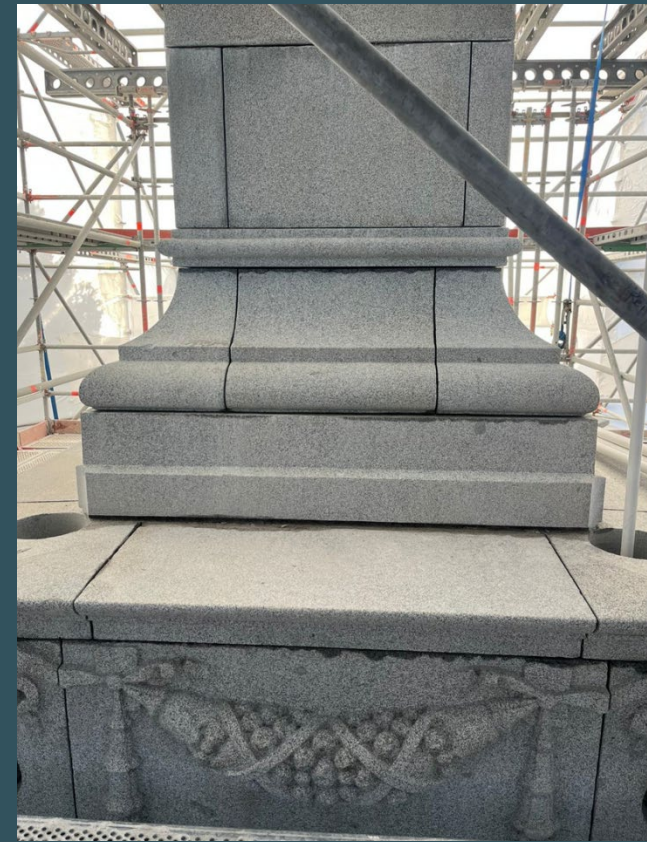
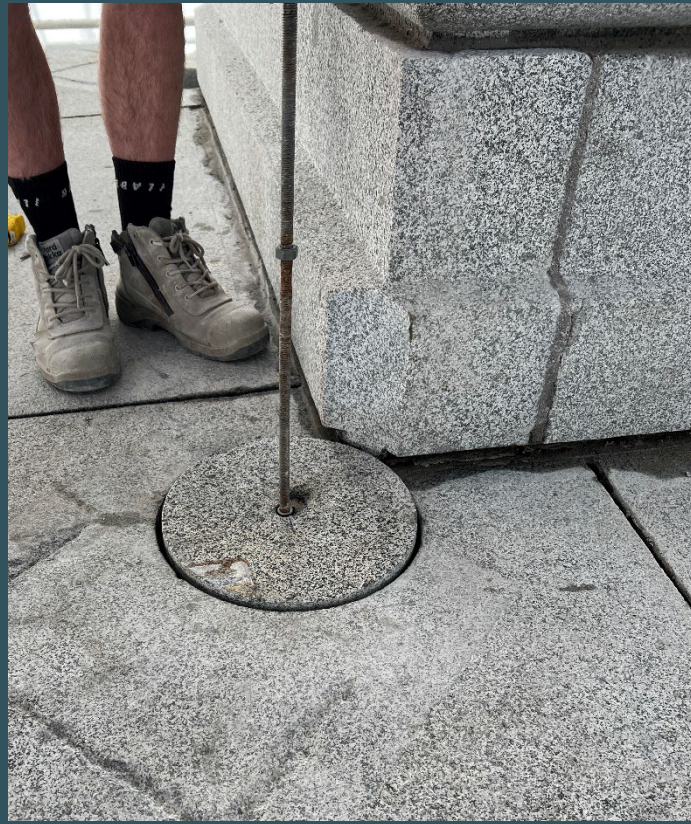
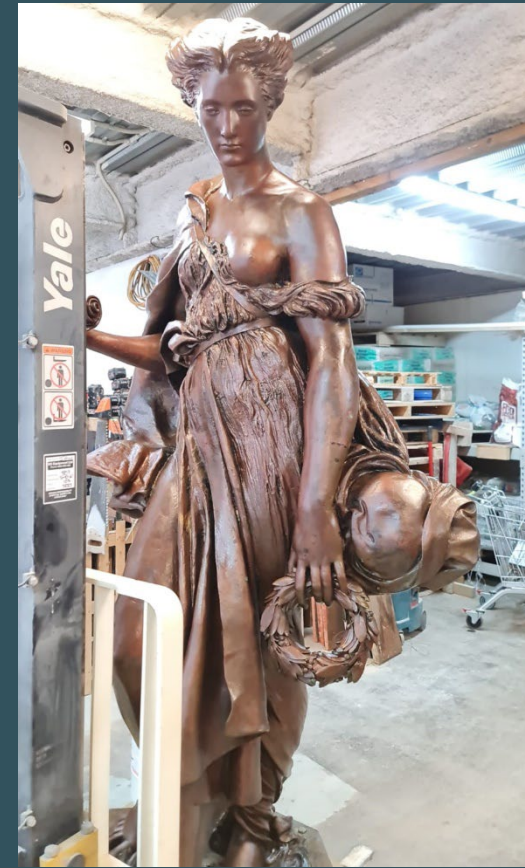
Completed ready for tensioning and replastering

Currently completing - cleaning, repointing, lead capping, replastering the Crypt, statue being reinstatement next week!

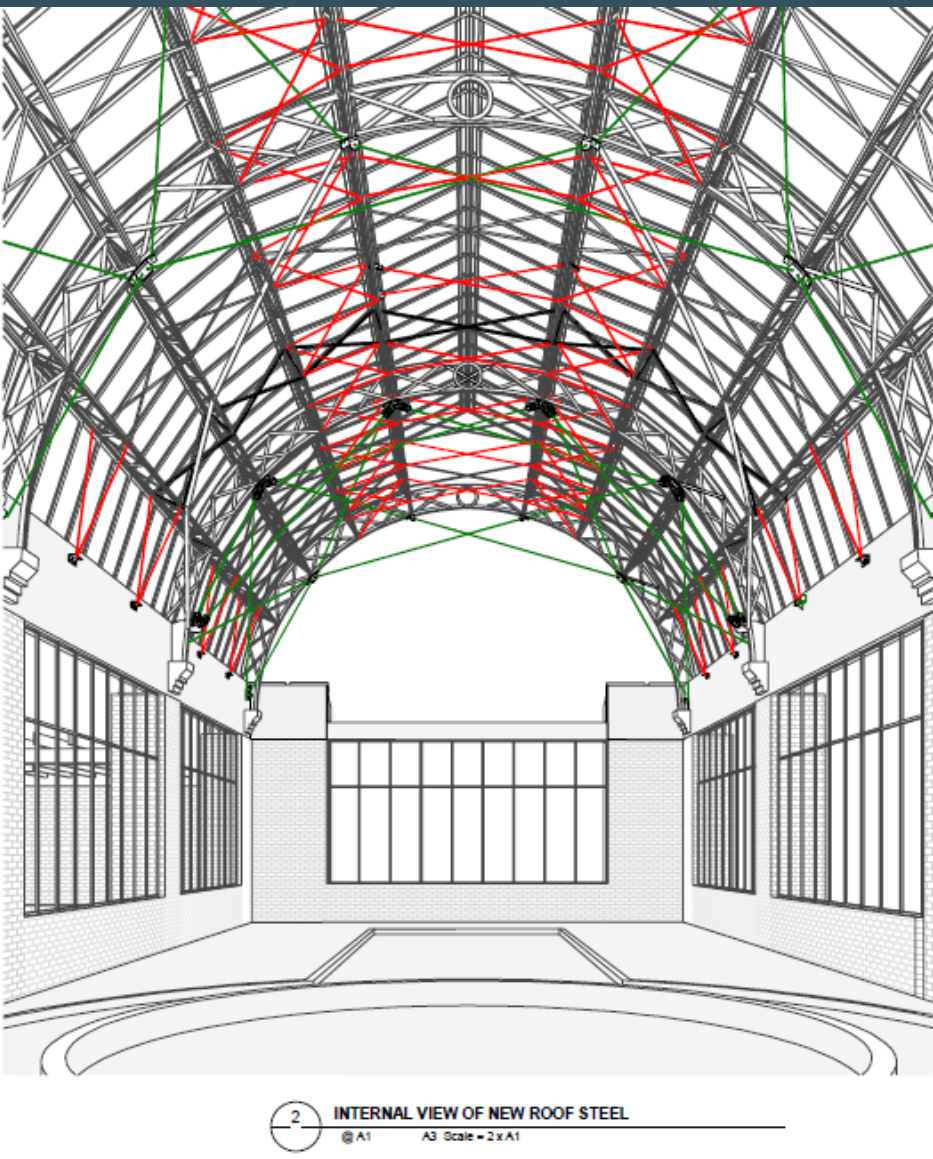
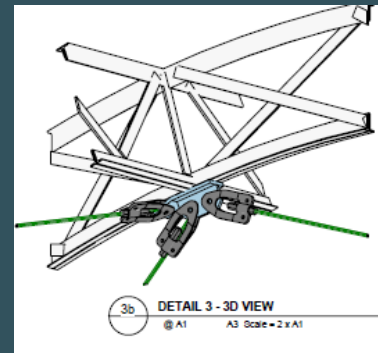
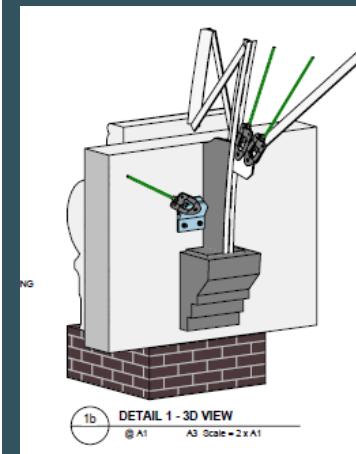
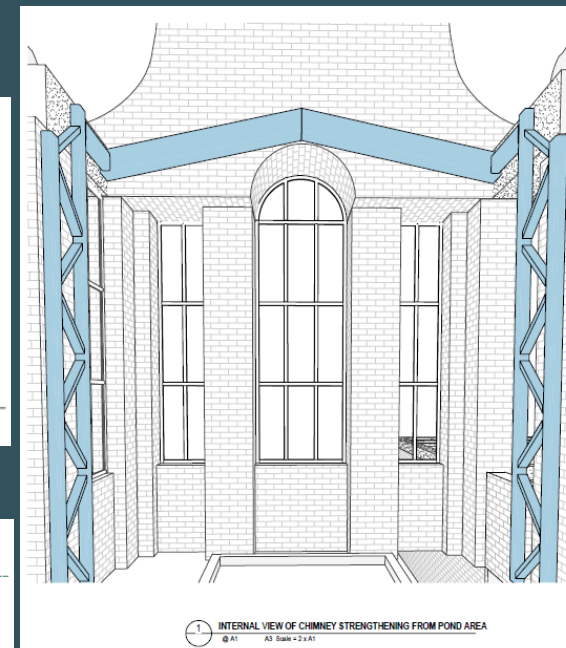
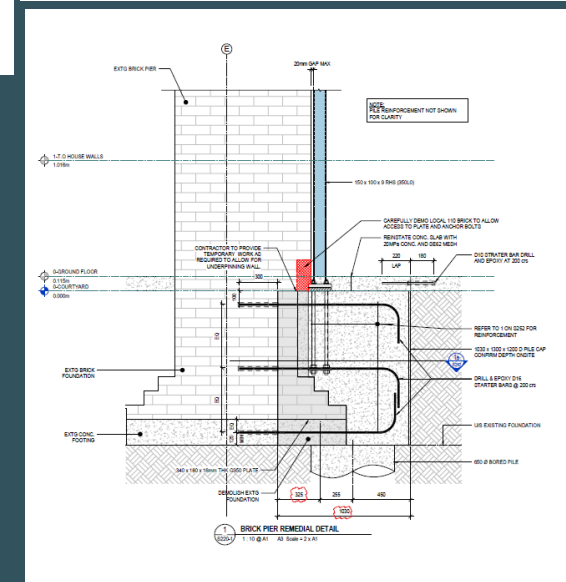
Condition Report

- Walls/piers – 67%NBS;
- Roof system excessively flexible and members insufficiently sized;
- Potential for cracking /shattering of brittle glass to roof – fall hazard;
- Tropical House chimney - potential fall hazard;
- Boiler House roof required a diaphragm;

1. Install diagonal tension bracing to the iron roof structure;
2. Supplement critical iron roof members;
3. Upgrade and underpin the chimney;
4. Add diaphragms to the Boiler House.

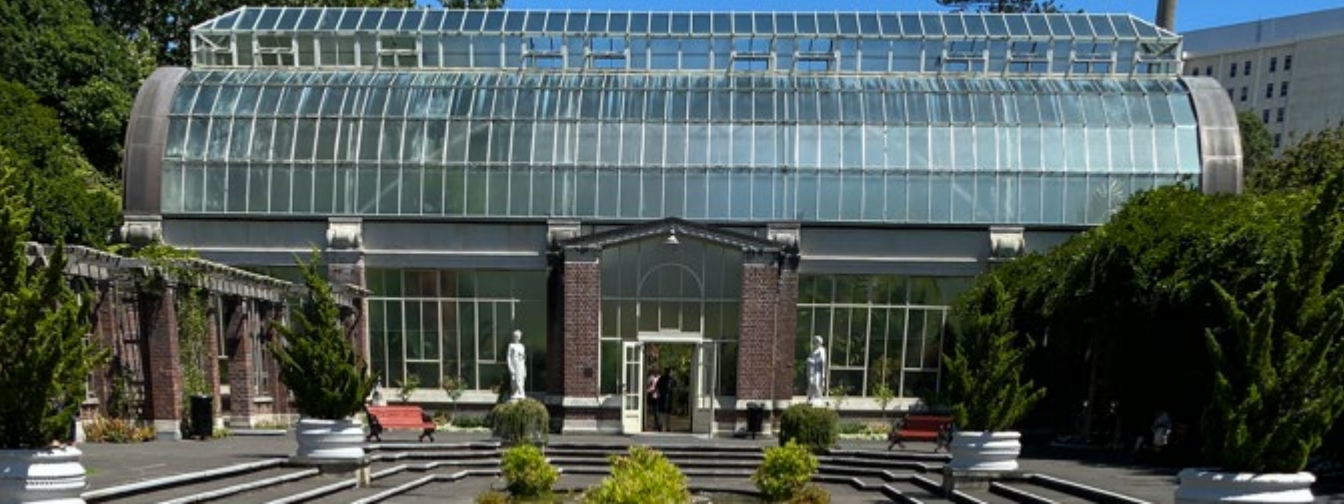
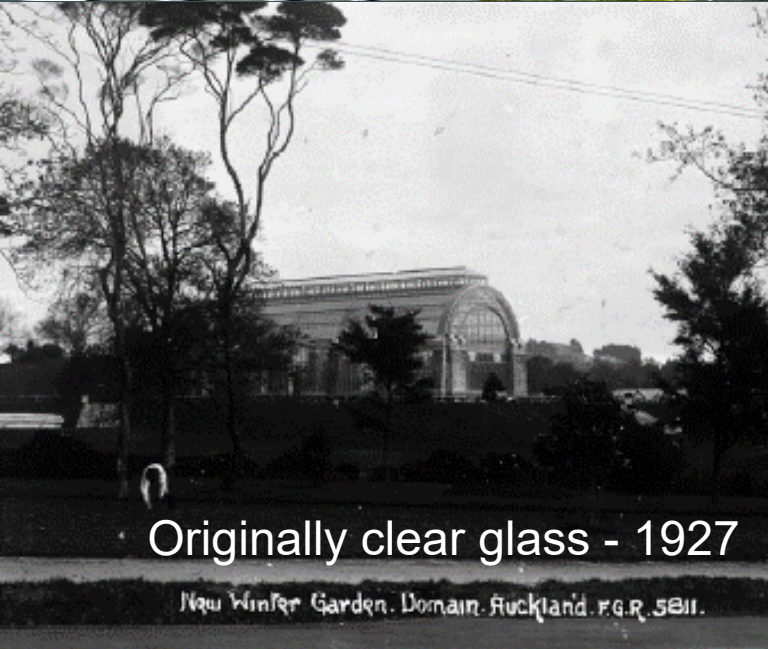
Stippolyte (obscure) - 2004/5

Originally clear glass - 1927

HSL Glass – 3mm layers of HS glass with an EVA film layer (double mechanical strength of annealed)

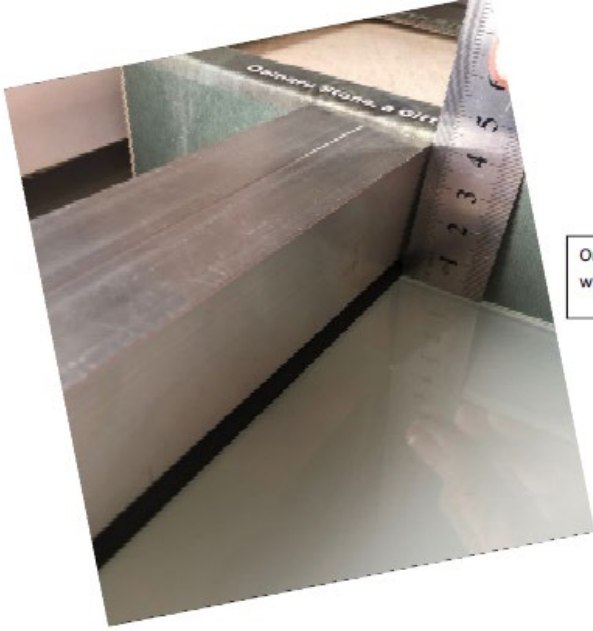
Original Design of New Roof Glazing bar with gasket

Original standard glazing 38mm high above glass
