ICOMOS New Zealand and
Historic Places Aotearoa Conference
12 November 2022

SEISMIC RESILIENCE – CHALLENGES FOR BUILT HERITAGE
CASE STUDIES

Tracey Hartley, Senior Associate – Salmond Reed Architects

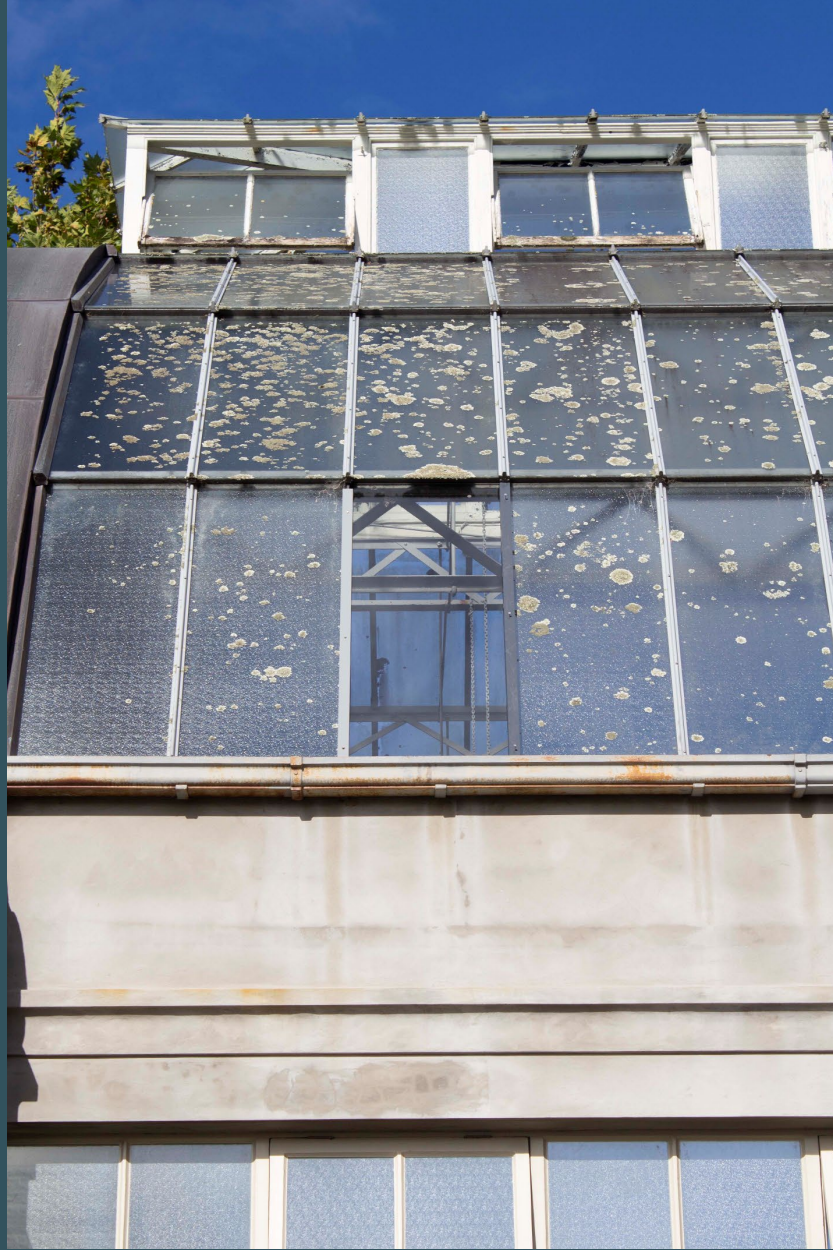
New Roof Glazing bar – note gasket missing

Redesigned to reduce the height of the bar by 8mm
